SEALGRID N11, Section 2, KZN Pavement Rehabilitation

Case Study

PROJECT: N11 Section 2, Ladysmith South IC – km 0,0 to Nkunzi River Bridge – km 47,75, KZN
CLIENT: SANRAL
DATE: Jan 2003 – June 2004
CONSULTANT: Ingerop Africa and Nankhoo & Associates JV
PRODUCT: GlasGrid® 8501, Sealmac®, Sealgrid
CONTRACTOR: Road Mac Surfacing [Pty] Limited
TRAFFIC: 6 000 vpd (20%)

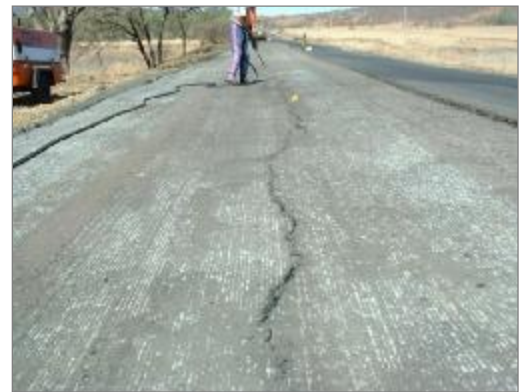
Most of the subgrade soils along this section of the N11 contain highly expansive soft plinthite derived from argillaceous Karoo sediments. Periods of excessive moisture, aggravated by local poor drainage facilities, especially in the vicinity of the culverts along, with periods of persistent drought, had resulted in large fluctuations in moisture content of the subgrade. This, coupled with a significant increase in heavy vehicle traffic, resulted in the localised development of severe cracking, with some cracks over 35 mm wide and extending deep into the subgrade, well below pavement layers.

Km 42,946 – Crack under milled surface, 2003

GlasGrid® was specified as a specialised method of repair where severe cracking and surface deformation were evident. The top 100 mm asphalt was milled out and visible cracks sealed with a fine slurry. A 40 mm asphalt levelling course was then placed and **GlasGrid® 8501** (100 x 100 kN/m) installed and overlaid with 60 mm base course asphalt

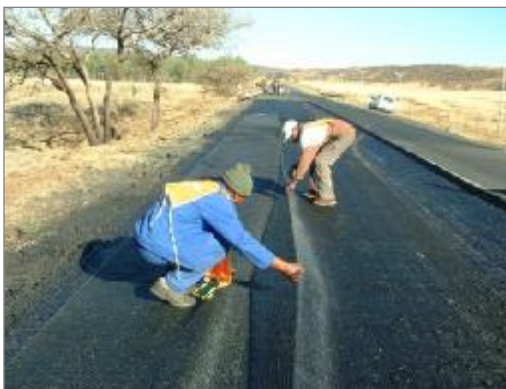
Km 42 946 – **GlasGrid® 8501** installation, 2003

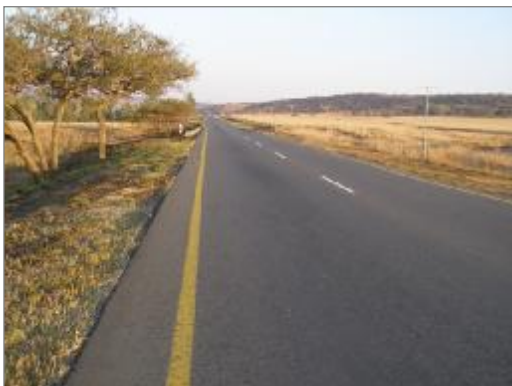
Km 42 946 – **GlasGrid® 8501** performance, July 2008

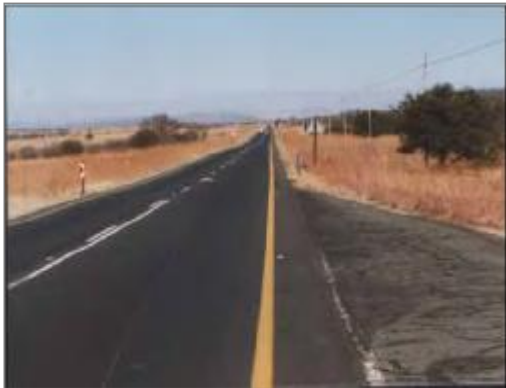
Km 16.28 – **GlasGrid®/Sealmac®** installation, 2003

A **Sealmac®** interlayer was then installed with a CAT60 bitumen emulsion tack at 0.8 to 1.4 l/m² followed by a 40 mm premix overlay.

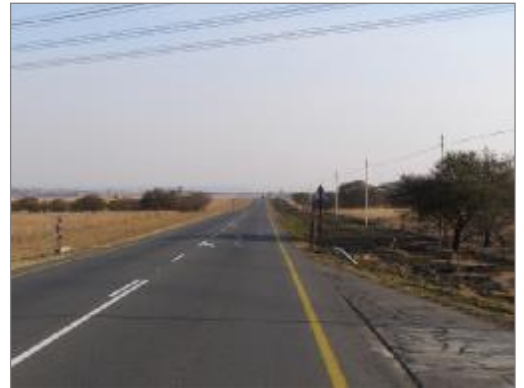
Km 16.28 – **GlasGrid®/Sealmac®** performance, July 2008. Note reappearance of cracks beyond culvert, outside area of geosynthetic repair

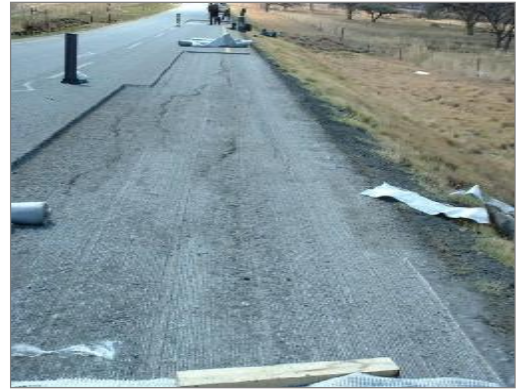
Km 32.200 – **Sealgrid** installation, 2003

REPAIRS IN AREAS WHERE DEEP MILLING WAS NOT JUSTIFIED
Sealgrid® 50 kN by 50 kN was installed in situations where the severity and depth of cracking over non-deformed areas were such that milling to 100 mm depth was not justified or practicable. 60 mm to 80 mm asphalt was milled out and residual cracks filled with a fine slurry. A tack of CAT60 coat bitumen emulsion was applied at 0.8 to 1.4 l/m² and **Sealgrid®** installed. Base course asphalt was inlayed to the existing level and overlaid with 40 mm premix.

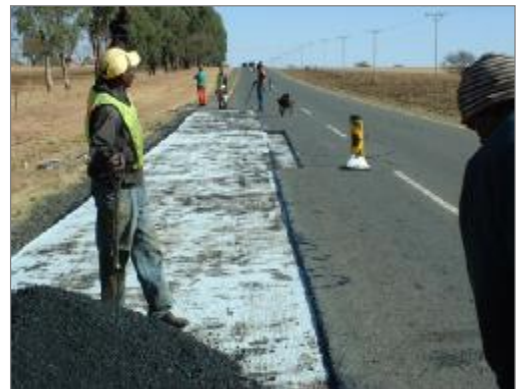
Km 32.200 – **Sealgrid** performance, July 2008. Note cracks have not reappeared
