**Drainage  
Golf Fairways  
Ruimsig, Gauteng**

**Case Study**

**PROJECT:** Fairway Drainage, Ruimsig  
**CLIENT:** Roodepoort Country Club  
**CONSULTANT:** Top Turf  
**CONTRACTOR:** Top Turf

**DATE:** Feb/Mar 2000  
**QUANTITY:** 1 400 m  
**PRODUCT:** **MEGAFLO**

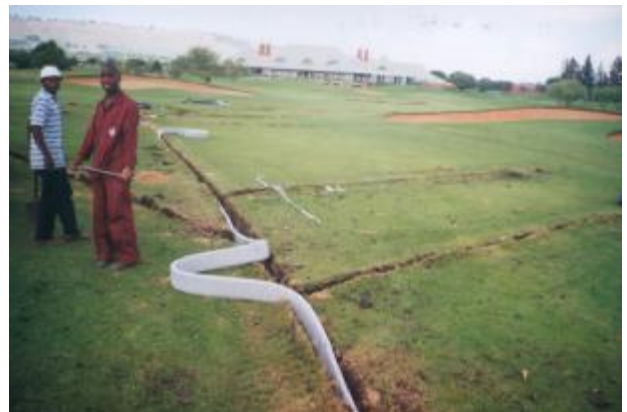
Placing **MEGAFLO** in herringbone trenches

Due to heavy summer rains some of the fairways had become waterlogged making play very difficult. The composition of the soil, a black turf, added to the problem. The water ponding on the surface was unable to drain away fast enough, thereby causing deterioration of the fairway grass. A subsoil drainage system was the only answer, and due to previous successes with the product, it was decided to use a 150mm high **MEGAFLO Panel Drain**.

This popular golf course is in constant use so **MEGAFLO** was an ideal choice, because disruptions were minimised when the narrow trenches were dug with a Ditch Witch and the **MEGAFLO** was quickly and effectively installed. A herringbone system was excavated to cover the affected areas. This called for a high number of panel drain connections, and the **MEGAFLO** junctions proved to work very effectively in these applications. After the **MEGAFLO** had been placed and connected in the trenches, clean river sand was used as backfill.

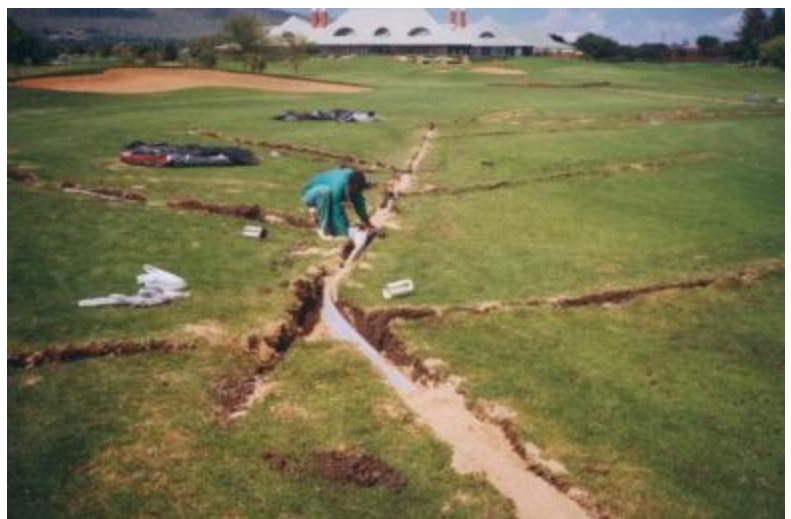
Placing of river sand backfill around **MEGAFLO**
