Tidal Erosion Rehabilitation Erosion Control Isipingo Beach, KwaZulu-Natal

Case Study

Project:	Isipingo Beach Rehabilitation	Date:	May 2011
Client:	Ethekweni Municipality	Product:	Geocontainer®
Consultant:	Ethekweni Municipality – Coastal Department	Quantity:	200 bags
Contractor:	Leomat

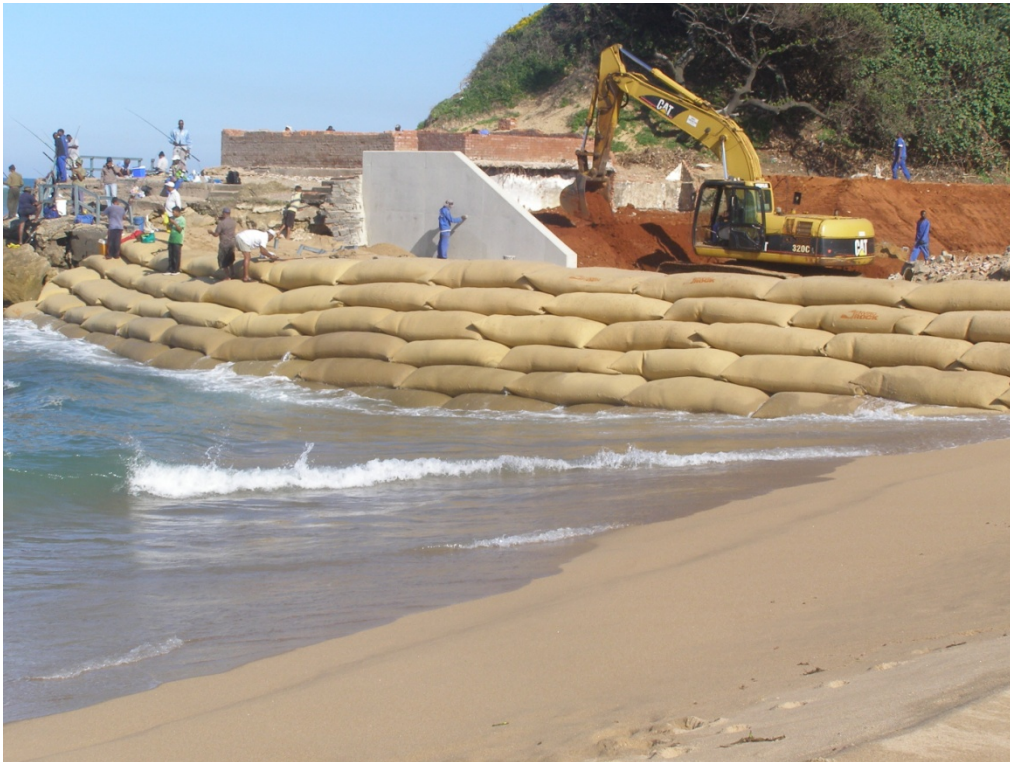
Due to some unusually heavy tidal behaviour, the beach at Isipingo, South of Durban, became eroded and threatened the stability of the adjacent car park. The strong tidal force eventually underscored the retaining wall making it urgent to rescue the threatened car park.

EnviroRock® Geocontainer® bags were used to create a defence wall to protect the car park from wave attack and erosion.

This was done by mechanically filling the bags with sand, hydro-dynamically compacting the sand and then positioning the back with mechanical slings bearing the weight.
