## Railway Line Embankments Erosion Control Sishen to Saldanha, Northern Cape

### Case Study

<b>Project:</b>	Transnet Orex Line Embankment Erosion	<b>Date:</b>	April 2010
<b>Client:</b>	Transnet	<b>Product:</b>	Neoweb
<b>Consultant:</b>	Transnet (in-house)	<b>Quantity:</b>	22 750 m <sup>2</sup>
<b>Contractor:</b>	RME

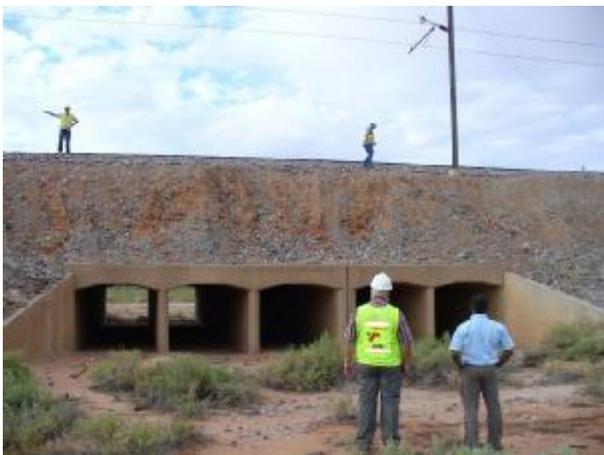
Originally constructed in 1976 the orex line runs from the town of Sishen in the Northern Cape to the port at Saldanha in the Western Cape. At the time of construction the embankments for the line were constructed using the insitu material. This decision was taken in order to eliminate the cost of importing material but the insitu material turned out rather dispersive and combined with the dry, arid nature of the terrain, resulted in severe erosion of the embankments.

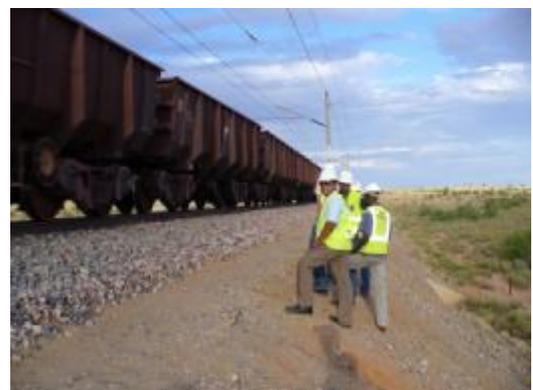
The design entailed clearing the slope of all the scrapings deposited during routine maintenance of the line, filling deep gullies and laying out the Neoweb panels. These were then secured in an anchor trench at the top of the embankment and pegged to the slope with metal reinforcing bars which were secured to the Neoweb using Neoclips. The Neoweb was then filled with material from a local borrow pit.

Strict safety regulations had to be adhered to as all the work was done while the line was fully operational. The stiff walls of the Neoweb boosted quick installation on the steep slopes resulting in limited exposure for the workers to the 4km long trains hurtling by at 100km/h.
