Road Rehabilitation Sinkhole Repair N14/P158-1, Centurion, Gauteng

Case Study

Project:	Road Rehabilitation, National Route N14/P158-1		
Client:	GauTrans	Date:	August 2006
Consultant:	Vela VKE	Product:	RockGrid™ PC 100/100
Contractor:	South Sound Civils	Quantity:	3 250 m ²

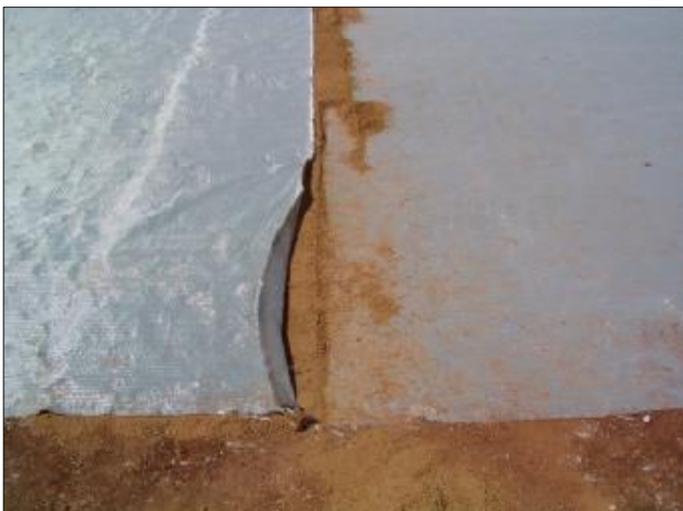
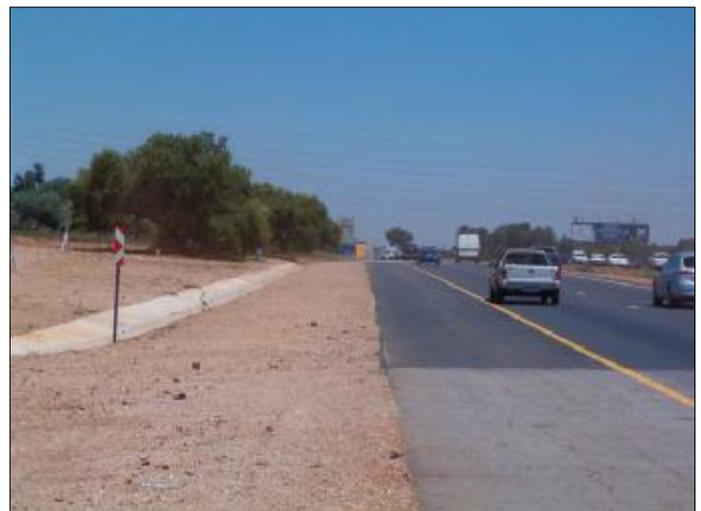
An overlap of 500 mm between adjacent roll widths of 5.0 m was an installation requirement. Sand was placed between the overlap to create friction between the layers.

Nails 15 cm long with washers were used to peg the **RockGrid™ PC 100/100** down to hold the fabric in place during placement of the fill layers.

Back-tipping followed to prevent machinery from driving on top of the **PC 100/100**, thereby incurring damage to the reinforcing elements.
