Road Rehabilitation Lanseria Airport ,Gauteng

Case Study

Project: Lanseria Airport Runway

Product: 1400m² Sealgrid

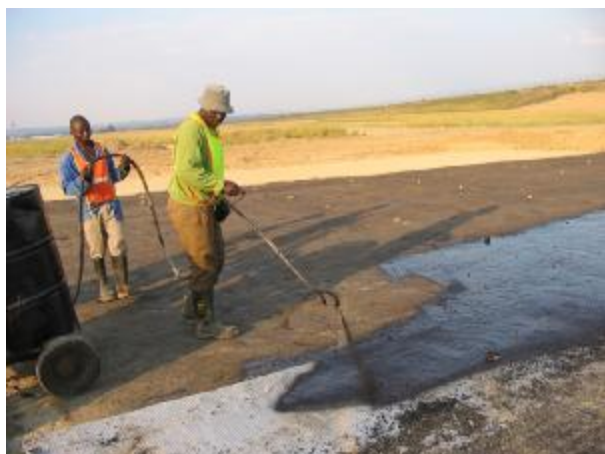
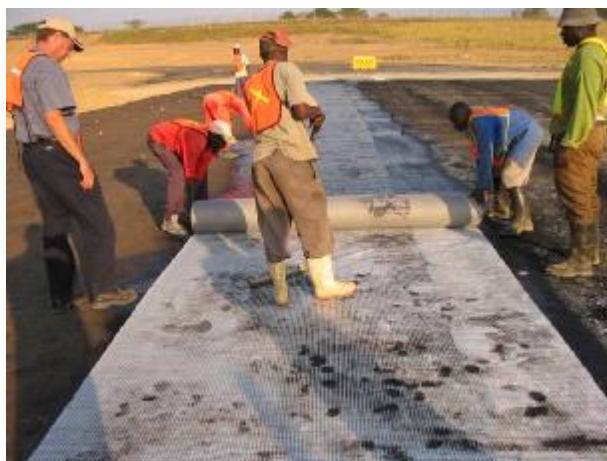
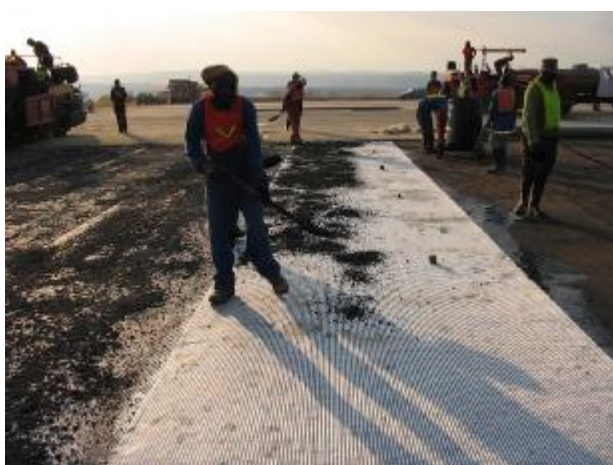
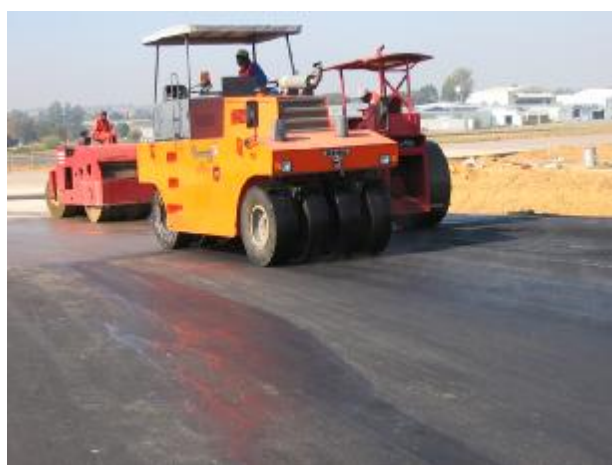
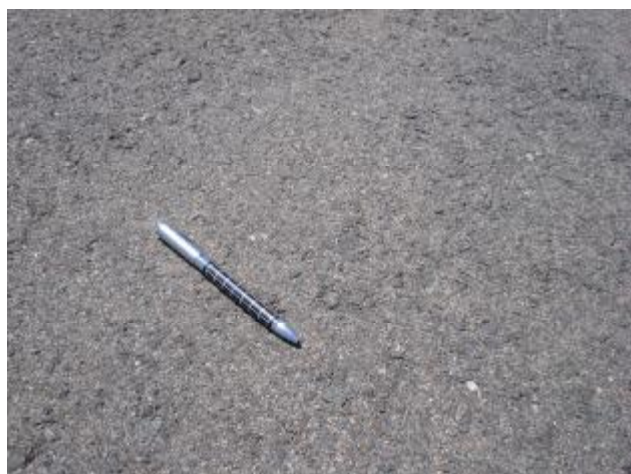
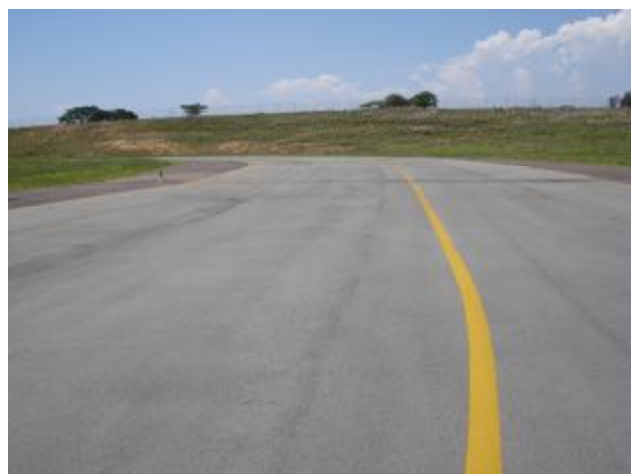
A 65% Cationic bitumen modified with 3% latex was used as a prime @1 litre/m². The Sealgrid was laid over the wet bitumen with the reinforcing yarns facing up. A pneumatic roller was used to roll the fabric down. A very light coat of approx. 0,4 litre/m² was applied over the areas where the bitumen had not come through the fabric. A thin asphalt armouring layer was spread over the wet fabric.
