CASE STUDY

Dam Linings | Water Containment | Stellenbosch, Western Cape

Product **Envirofix X800 5 000m²**

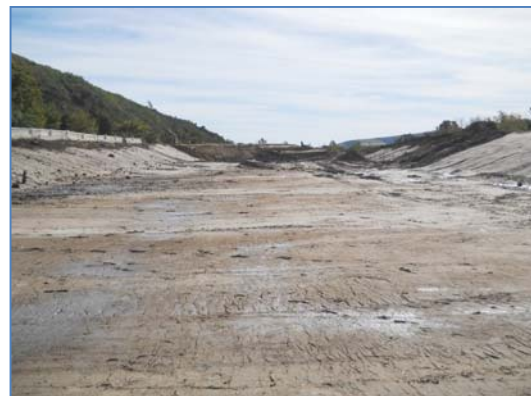
The re-shaped dam

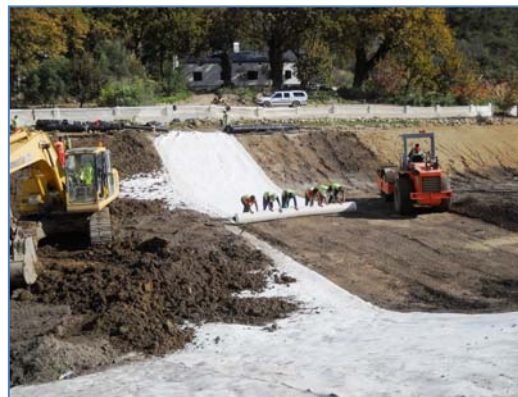
*Laying **Envirofix** GCL over the prepared surface*

Once the **EnviroFix** GCL was installed, it was covered with 300mm cover soil to confine and protect the GCL as well as maximise the hydration of the bentonite.

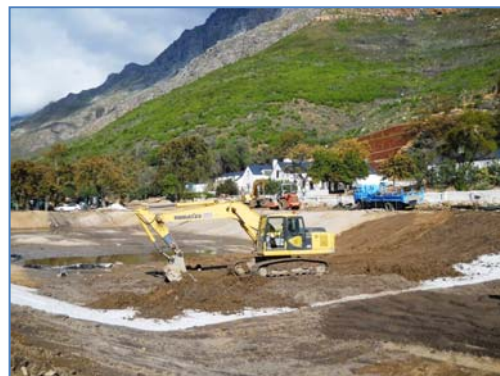
*The layers - prepared surface, **Envirofix**, cover soil*
