CASE STUDY

Water & Waste Containment | Dam Lining | Boston, KZN midlands

Product **EnviroFix® X1000** | 2 040m²

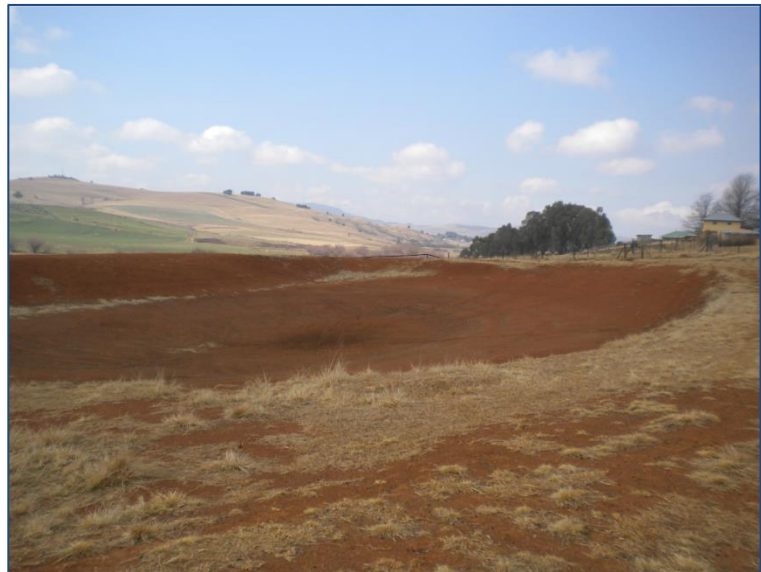
The new dam slopes prepped for lining

An inspection of the site suggested that the steep slopes of the dam be made more gradual to facilitate the installation of **EnviroFix®** GCL. This was achieved using a Bobcat.

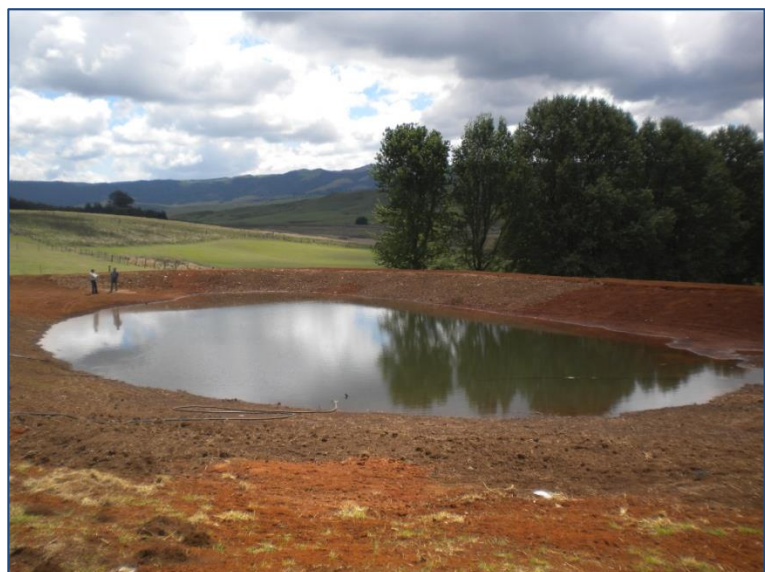
*Filling the completed dam lined with **EnviroFix®** GCL*

The GCL was covered with a 300mm confining layer of compacted soil to optimise the very low permeability of the liner and to keep it hydrated should the water level drop below operating level for any length of time.
