CC5™ Bulk Rolls

Campana-Malacatos,  
Provincia de Loja,  
Ecuador

CC5™ was used to  
remediate an failing  
irrigation channel.

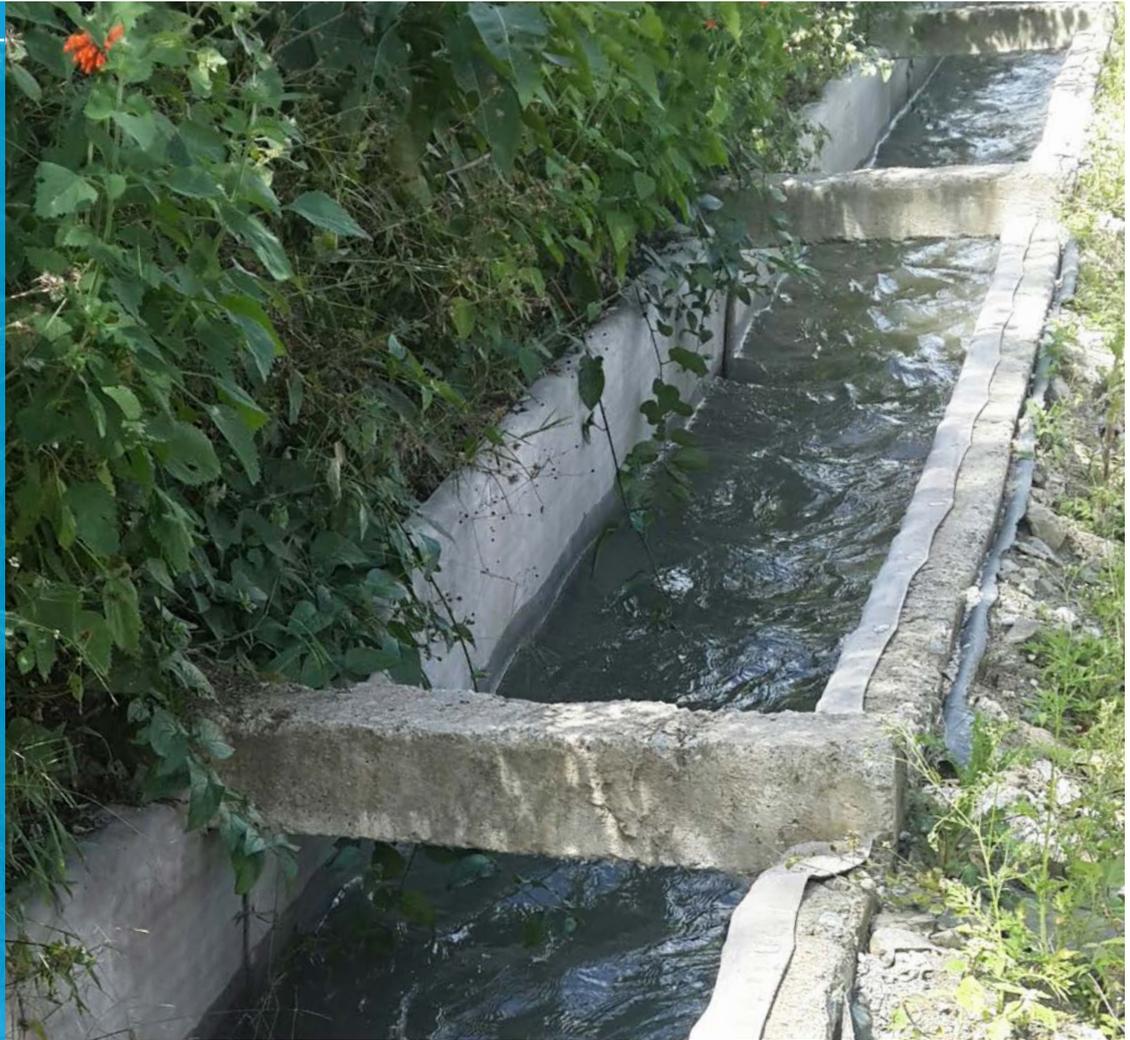
Completed installation

In total, 261sqm of CC5™ were installed in 4 days by 5 people with some inclement weather. **The use of CC meant the works had minimal affect on the surrounding agricultural businesses and the channel was in use without water loss after 24 hours.**

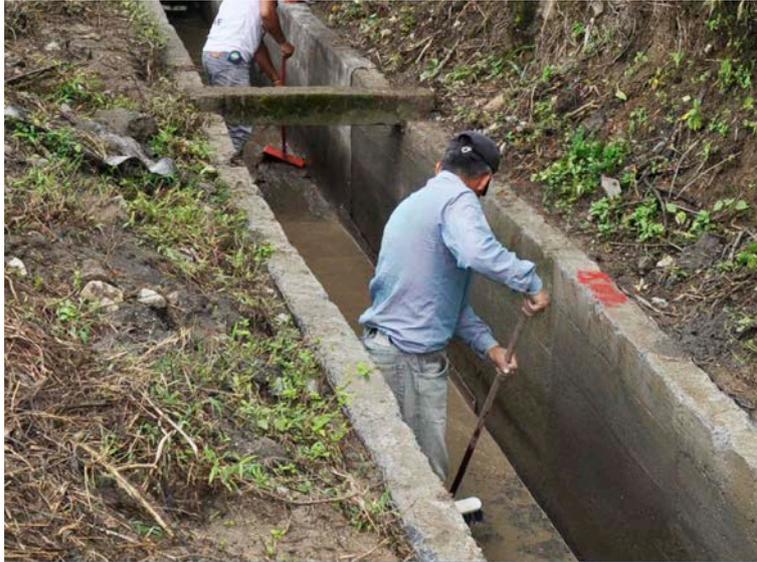
Cleaning the channel

The channel was drained and cleaned with a pressure washer and stiff bristle broom to ensure intimate contact between the CC and the concrete substrate. Bulk rolls were mounted onto a spreader beam and batched to length on site with a wireless disc cutter. A 3 layer longitudinal layup was used, with the two side layers overlapping the base layer by 100mm. These overlaps were jointed via concrete nails with washers to prevent pull through, and a 6mm bead of adhesive sealant was used to increase the impermeability of the joint. Hydration was achieved via a hose with spray nozzle attached. A second hydration was completed an hour later to ensure proper hydration of the CC5™ on the vertical surfaces.

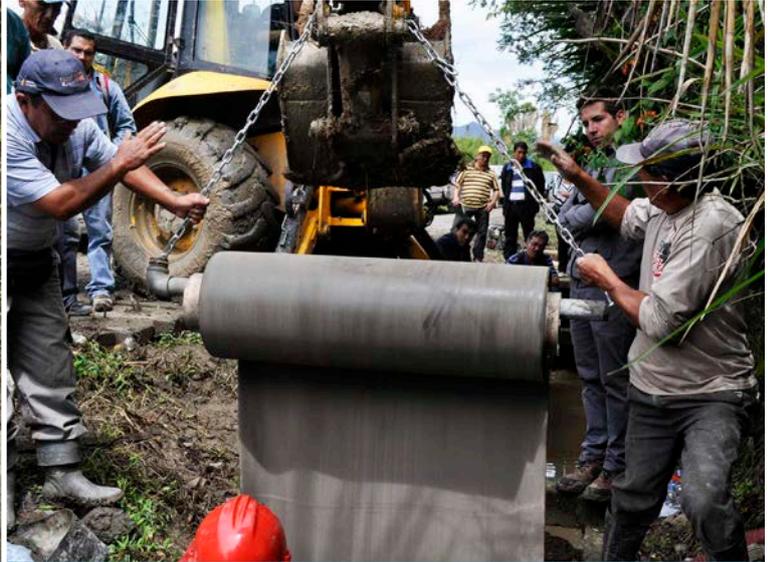
Unrolling the first layer of CC

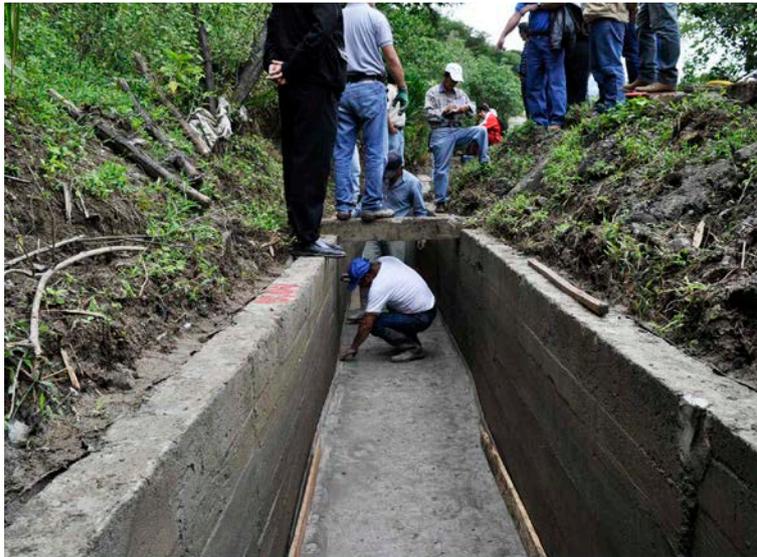
Ensuring intimate contact with the substrate

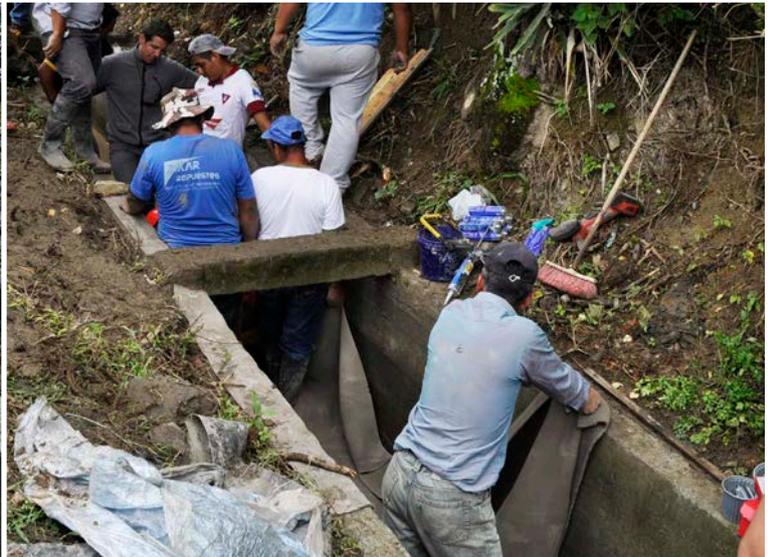
Placing the third layer of CC

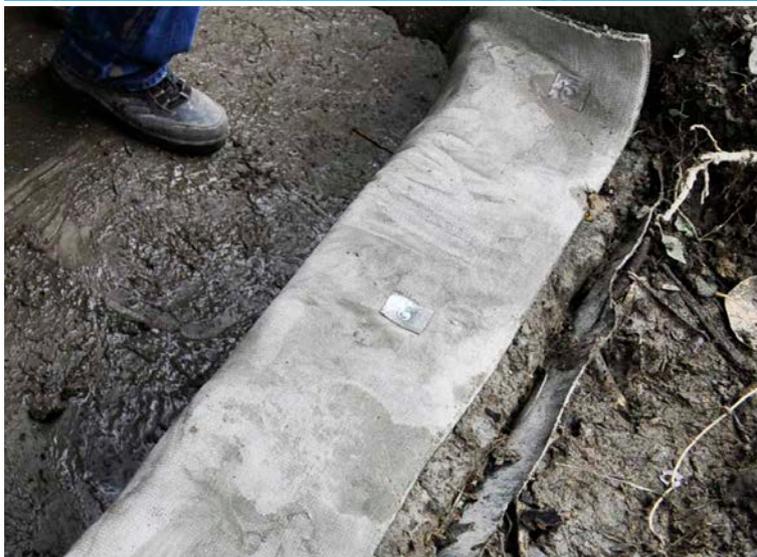
Concrete nail with washer

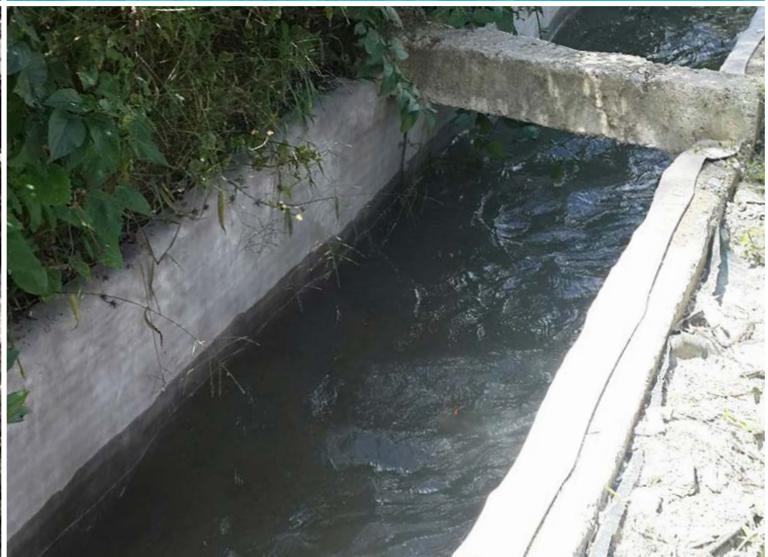
The finished channel in use
