CASE STUDY

Barrier | Canal | N4 Watervalboven, Mpumalanga

Sep 2016

Product **Concrete Canvas CC5** | 50m²

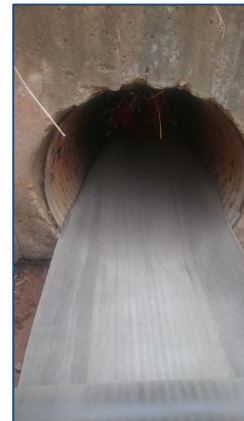
Concrete Canvas was manually pulled through the culvert

Prior to installation of **Concrete Canvas CC5**, the culvert was cleaned of all debris and standing water. The head wall at the inlet end, was chipped away in order to create an exposed edge for attachment of the GCCM material. Man-portable rolls of **Concrete Canvas** were cut to more manageable lengths of eight metres and carried down the slopes to be manually drawn through the culvert.

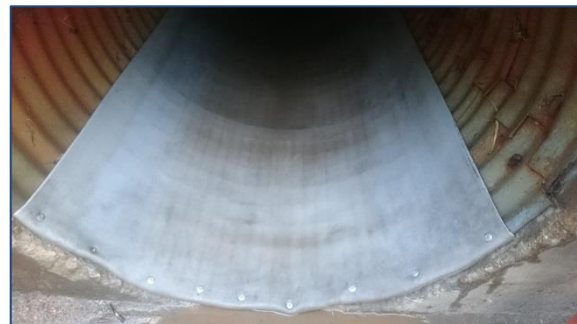
Concrete Canvas was pop-riveted to the existing steel culvert

Once in position, each length and its 100 mm overlap were pop riveted onto the existing steel culvert. To complete installation, the **Concrete Canvas CC5** was well hydrated by hose. Within 24 hrs, 80% strength (30MPA) was attained and after ten days, the **Concrete Canvas** was fully set.

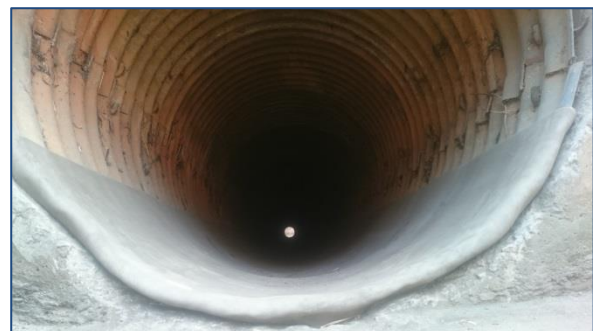
Once hydrated, 80% of the strength was achieved in 24 hours
