CASE STUDY: Ref 906

Lynnwood Bridge Pavement repairs, Pretoria, South Africa, 2014

Surface deformation caused by poor compaction over buried services repaired using TriAx geogrids

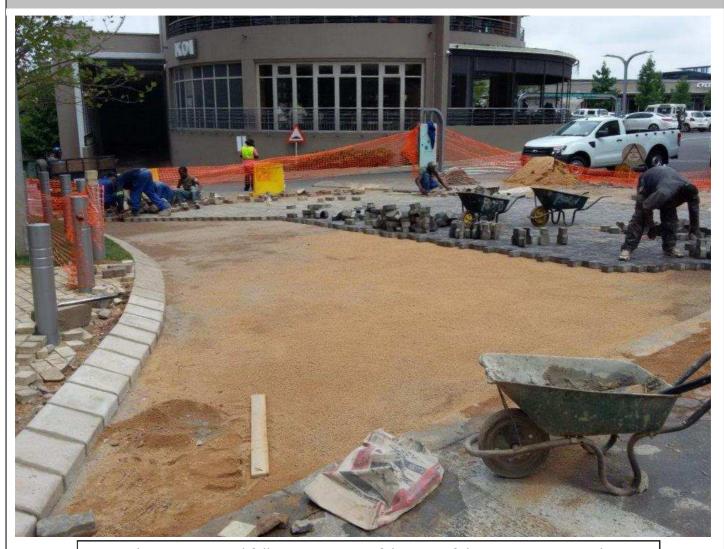
Paving being reinstated following a successful repair of the sagging support layers

• At the time of construction of this corporate park and shopping mall development, large diameter pipelines were installed beneath a portion of the road way. Due to insufficient compaction of the material over the services, the material started to sag resulting in uneven ride quality and poor drainage over the affected area.

• The Engineer advise the contractor to remove 300mm of material, place the TriAx TX 160 geogrid and import G5 material to install over it. The granular G5 material interacted with the TriAx geogrid produced a mechanically stabilized sub-base. The TriAx geogrid helped distribution the applied load minimising the pressure on the lower fill layers.

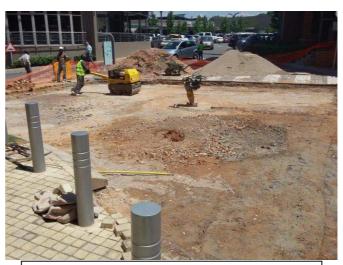
The paving was removed and existing fill excavated to 300mm depth.

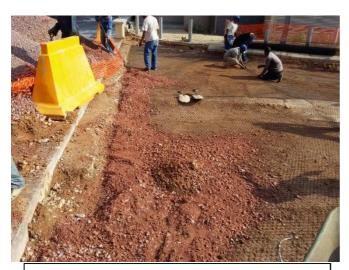
The roadbed was rolled to provide a flat surface to lay the TriAx geogrid.

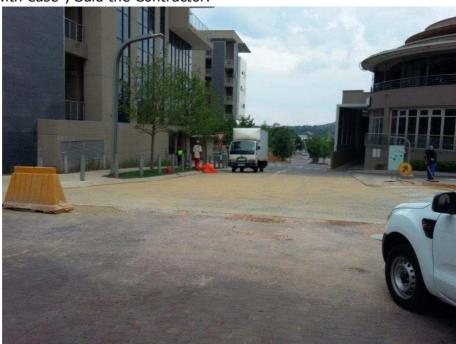
The completed roadway was back in use without causing major disruption.
