CASE STUDY

Roads | Surface Rehabilitation | N1 Bloemfontein

Product **Sealmac[®] 200mm strips**

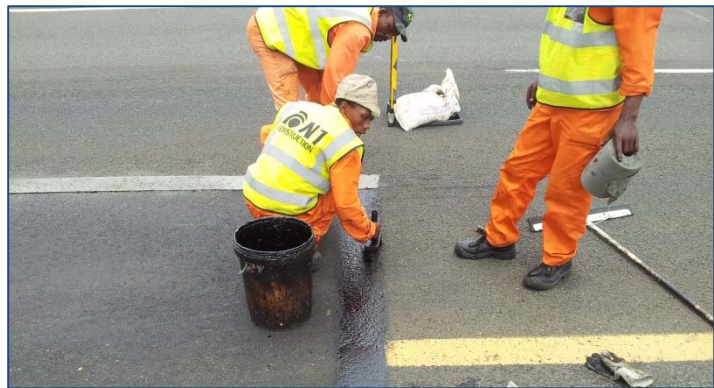
*A bitumen emulsion is applied to the road surface before applying **Sealmac[®]** strips*

A tack coat of CAT 65 bitumen emulsion was applied to the joints. **Sealmac[®]** strips were then placed into the tack coat with the joints lying along the centerline of each strip, thereby allowing equal widths of geotextile on either side. Usually a saturation coat of bitumen is then applied followed by a wearing course layer, but plans were already in place for resealing this particular section of the N1 and this pre-treatment of the cracks with **Sealmac[®]** strips would effectively be covered by the new full width surfacing.

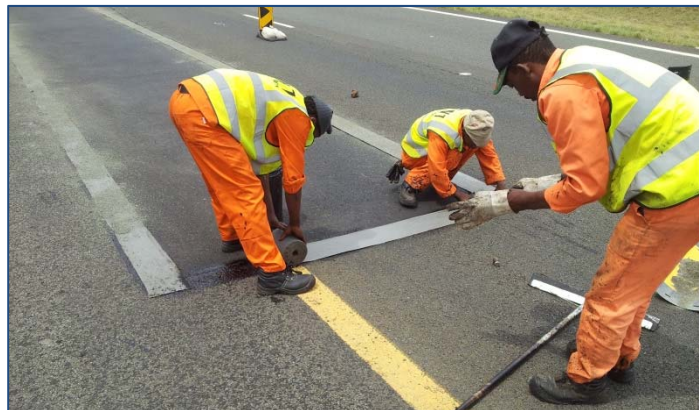
***Sealmac[®]** strips are rolled out over the tack coat and any creases removed by squeegee*

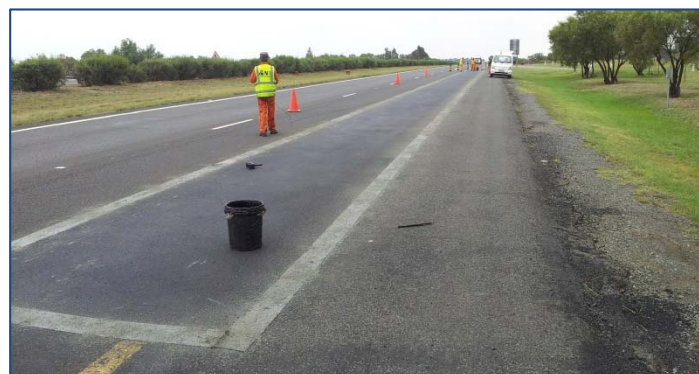
*The completed temporary repair work using **Sealmac[®]** strips*
