## CASE STUDY

### Roads | Surface Rehabilitation | N1 Polokwane

Apr 2014

Client National Transport Research Centre (NTRC)  
 Contractor Grinaker / Sixbar Trading  
 Product **Sealmac**<sup>®</sup> | 100m<sup>2</sup>

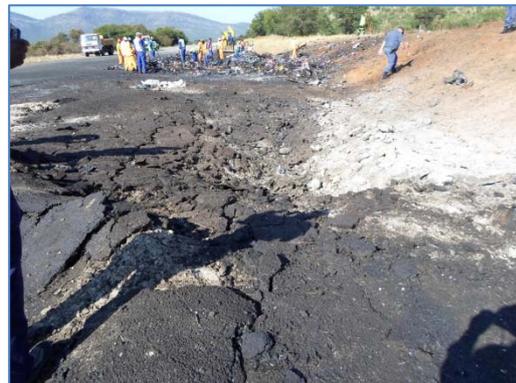
After an explosive accident occurred on a section of the National highway, the resulting crater needed repairing particularly urgently because of expected high traffic volumes over the ensuing Easter weekend.

*The road accident damage*

All debris caused by the blast was removed. The layer works were filled with crush-run which was then compacted and sprayed with a tack coat. **Sealmac**<sup>®</sup> was installed over the tack coat and covered with a fine layer of 4.5 mm stone aggregate to provide skid resistance.

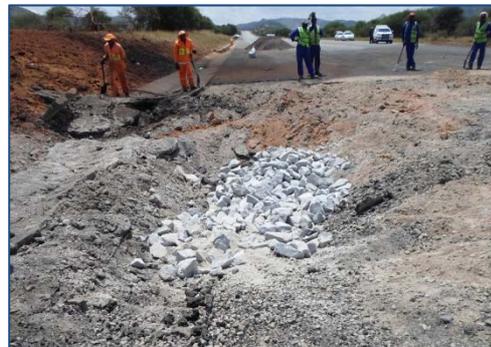
*The layer works were filled with crush run*

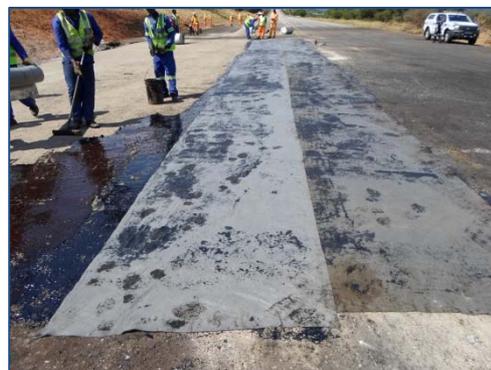
*A tack coat was applied over compacted layer works and **Sealmac**<sup>®</sup> laid on top*

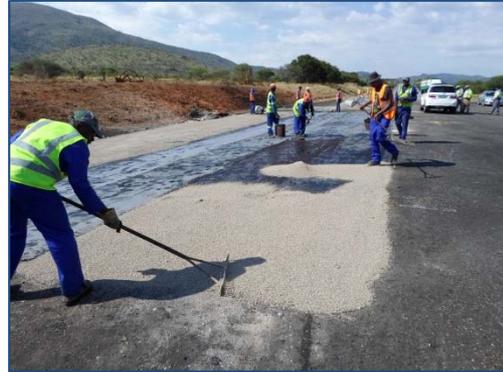
*A skid resistant stone layer applied over **Sealmac**<sup>®</sup>*

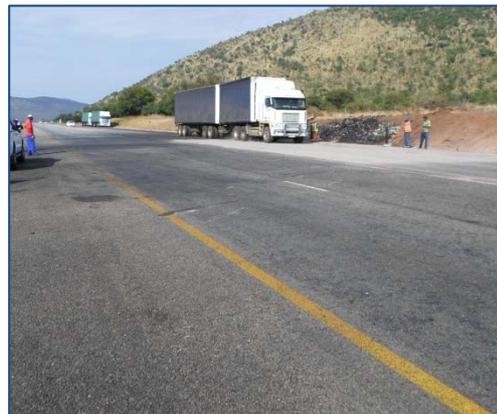
*The road was ready for traffic after 1 day's repair works*

One setback was that the side drain channel was destroyed by the blast and there was not enough time to have it repaired. Consequently it caused water ingress into the road layers, which resulted in some deformation, but no instability to the road.

These include ease of installation, low cost, lower maintenance costs and prolonged fatigue life. It was installed in just one day and the repaired road performed well under the larger than usual volume of traffic.
