## CASE STUDY

Roads | Surface Rehabilitation | N1 Winburg

Oct 2014

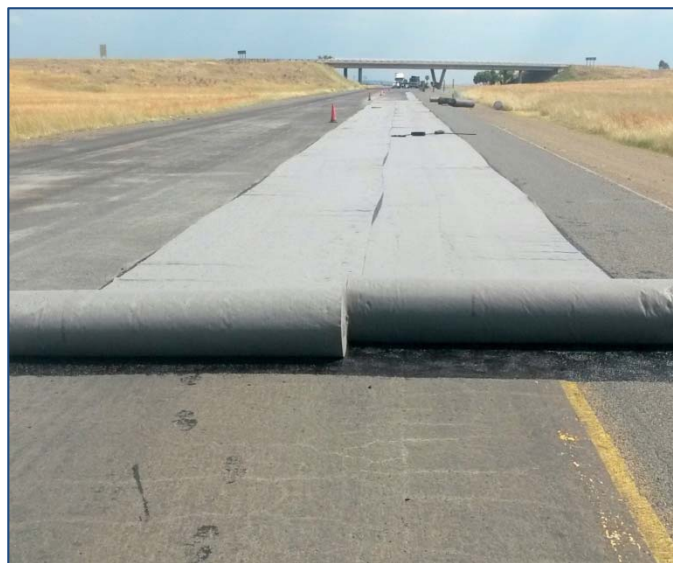
When a severely cracked section was delineated on the N1 at the R708 intersection, a solution was needed to prevent further deterioration of the road surface prior to resealing.

*The road surface had been cracking and required repair*

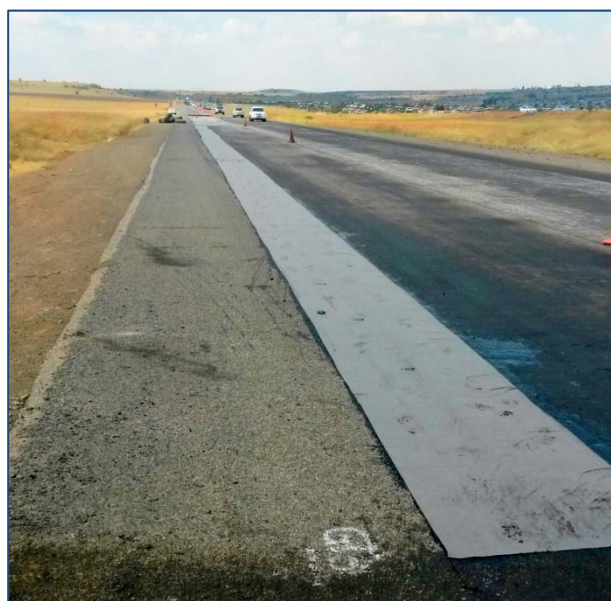
*Sealmac was applied over a tack coat*

After applying a tack coat of Rubspray 70/5 (a high viscosity cationic spray grade bitumen emulsion with 70% binder content and 5% net SBR latex) onto the cleaned cracked area identified for treatment, **Sealmac**<sup>®</sup> was laid onto the wet emulsion. This was followed by a saturation coat of Rubspray 70/5 which conforms to the SC-E2 specification for modified emulsion for surface seals.
