## Roads Reinforcement Sub-grade Stabilisation N6 Section D Griffiths St – R61, Queenstown

### Case Study

<b>Project:</b>	N6 Section 3 & 4 Rehab Ezibeleni - JJ Serfontein Phase 2	<b>Date:</b>	May 2011
<b>Client:</b>	SANRAL	<b>Product:</b>	RockGrid PC 50/50
<b>Consultant:</b>	Goba	<b>Quantity:</b>	27 509 m <sup>2</sup>
<b>Contractor:</b>	Norland Construction	<b>Rep:</b>	Julian Maastrecht

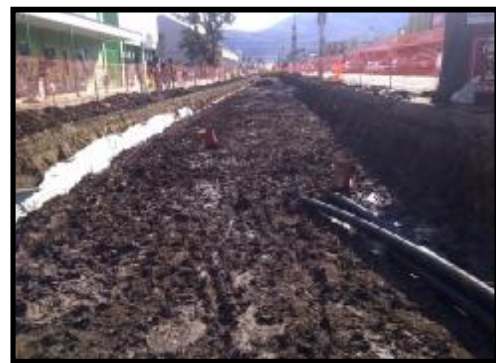
*Waterlogged box cut*

accommodation. Problems were further encountered when higher than average rainfall and expansive in situ clay sub-grade soils of CBR 4 - 5 and  $PI \geq 9$ . This resulted in a waterlogged box cut condition.

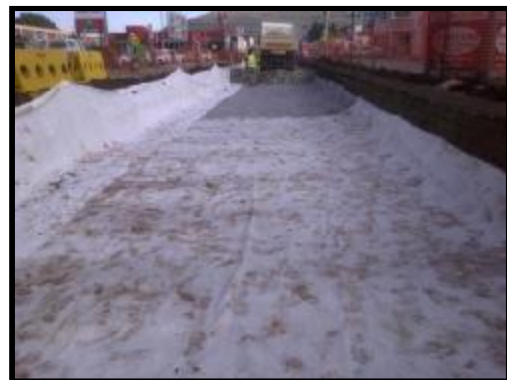
*Rockgrid PC reinforcing laid in trench*

A proposed rock layer was placed on the sub-grade, but found to be heaving during compaction. Kaytech **Rockgrid PC 50/50** was then placed between the rock fill and sub-grade to separate, stiffen and reinforce the rock fill layer.

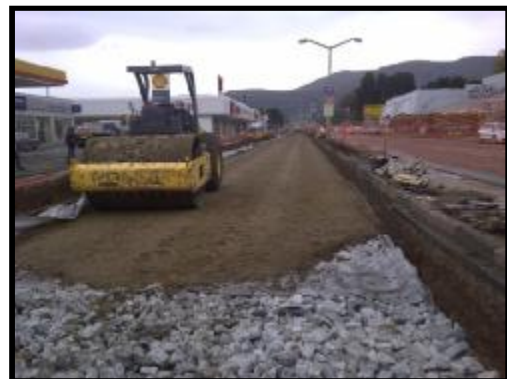
*G5 sub-grade placed on reinforced layer*

The **Rockgrid PC 50/50** worked well, allowing for subsequent layers to be properly placed and for heavy machinery to move over the layers. This resulted in time-saving and a successfully completed project. The technique was adapted for a greater portion of the contract.
