Project Info

CC5 bulk rolls

Malkerns, Swaziland

Concrete Canvas SA

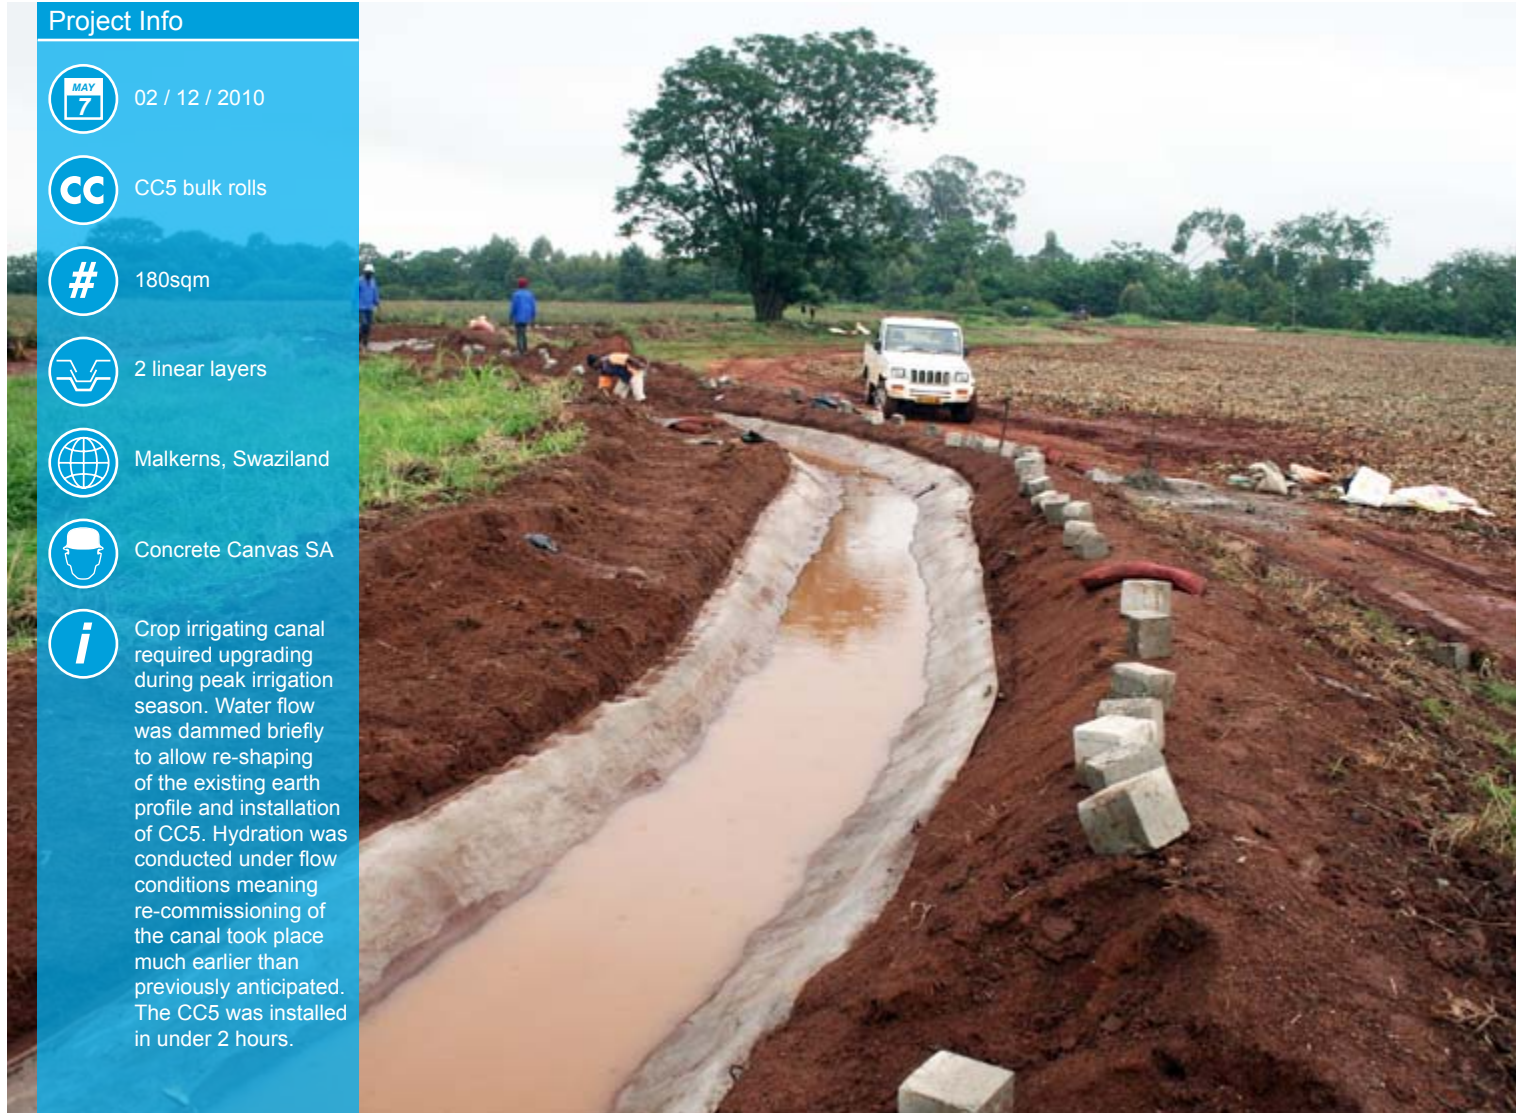
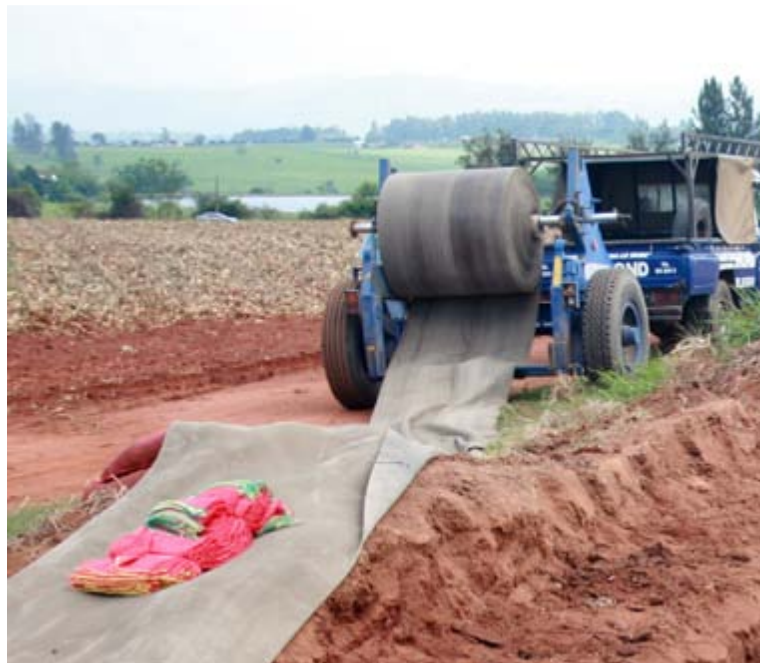
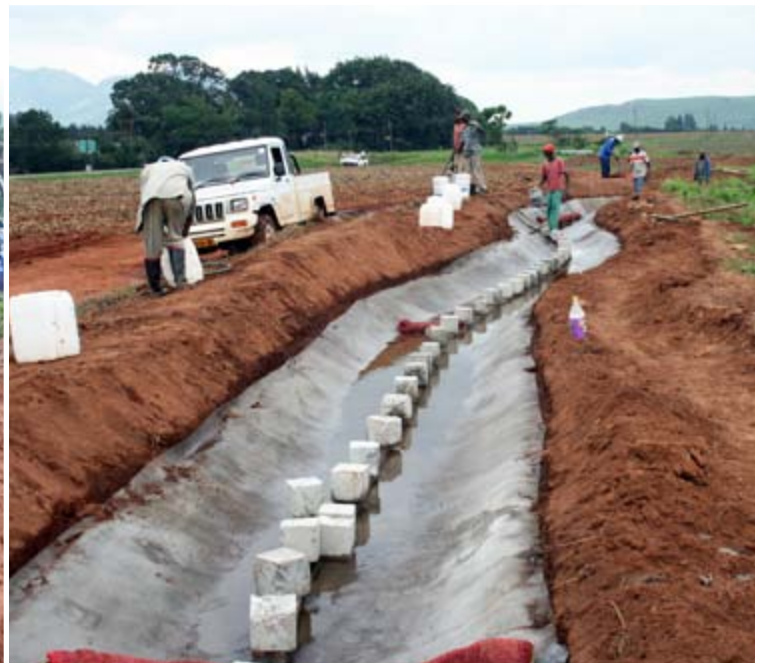
Crop irrigating canal required upgrading during peak irrigation season. Water flow was dammed briefly to allow re-shaping of the existing earth profile and installation of CC5. Hydration was conducted under flow conditions meaning re-commissioning of the canal took place much earlier than previously anticipated. The CC5 was installed in under 2 hours.
