CC13™ Bulk Rolls

Vazante, Minas Gerais, Brazil

CC was used to line drainage ditches and a drainage lagoon constructed to decant alkaline mine water.

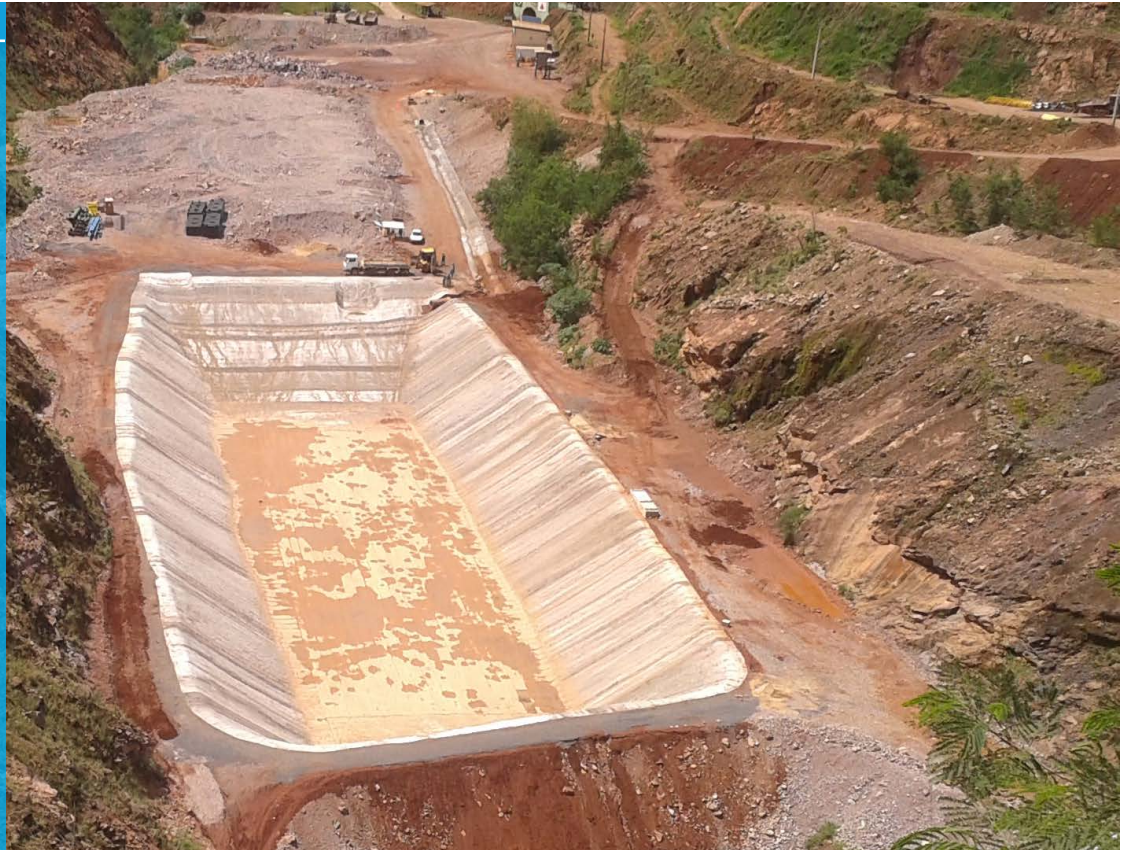
Completed installation

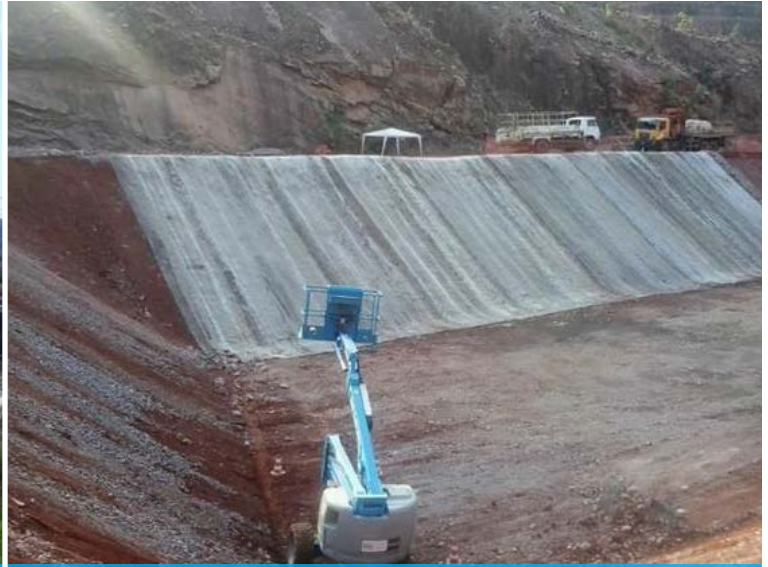
CC layout

Vegetation was removed and the lagoon slopes graded and compacted. Bulk rolls of 13mm thick CC (CC13™) were mounted onto a spreader beam and unrolled down the lagoon slope faces, before being cut to specific profile length. Subsequent layers overlapped the previous by 100mm and pegs were inserted through the overlaps at the crest. Everbuild Clearfix adhesive sealant was used to join the overlaps, and the joints were compressed to ensure an optimal bond. Hydration was achieved using a water truck and hose with spray nozzle attached.

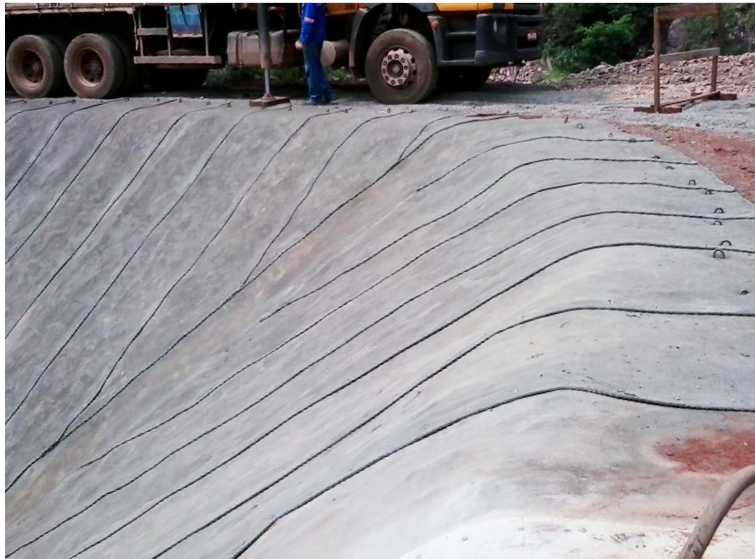
CC pegged at the crest

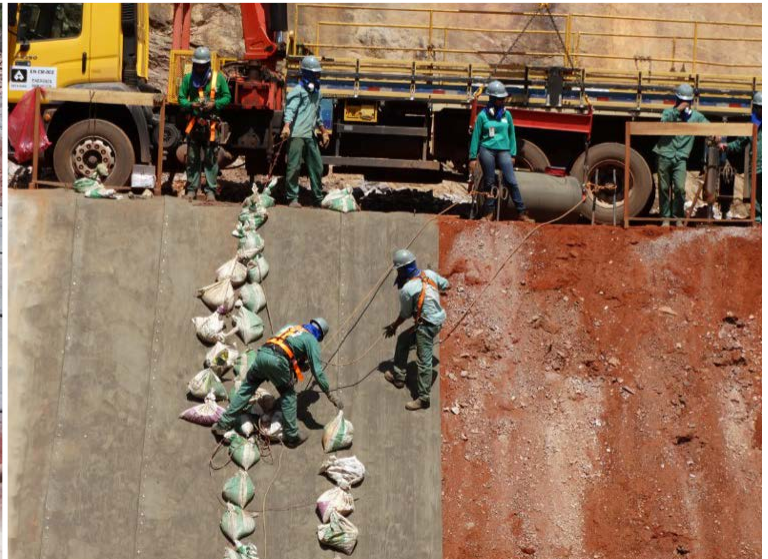
Compressing the joints

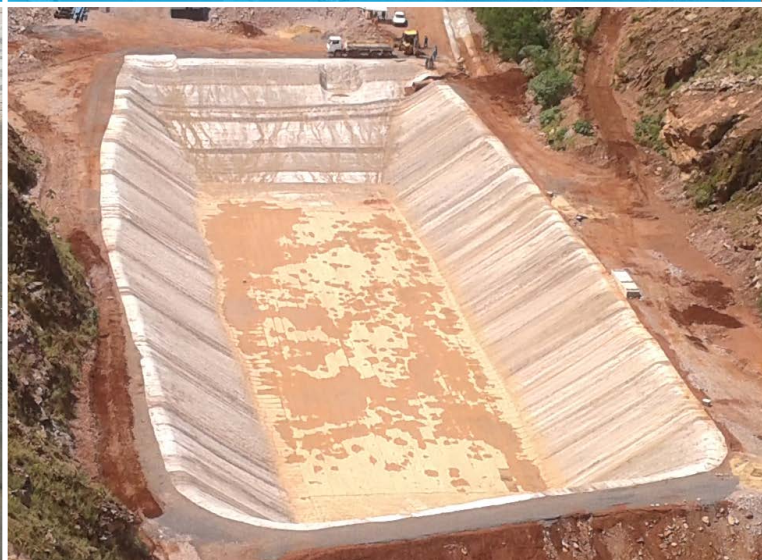
The completed lagoon
