Project Info

CC8™ Bulk Rolls

Spence Mine Site,
Antofagasta, 2nd region,
Chile

CC8™ used to collect
water contaminated
with sulphuric acid and
direct it towards holding
pits for later treatment.

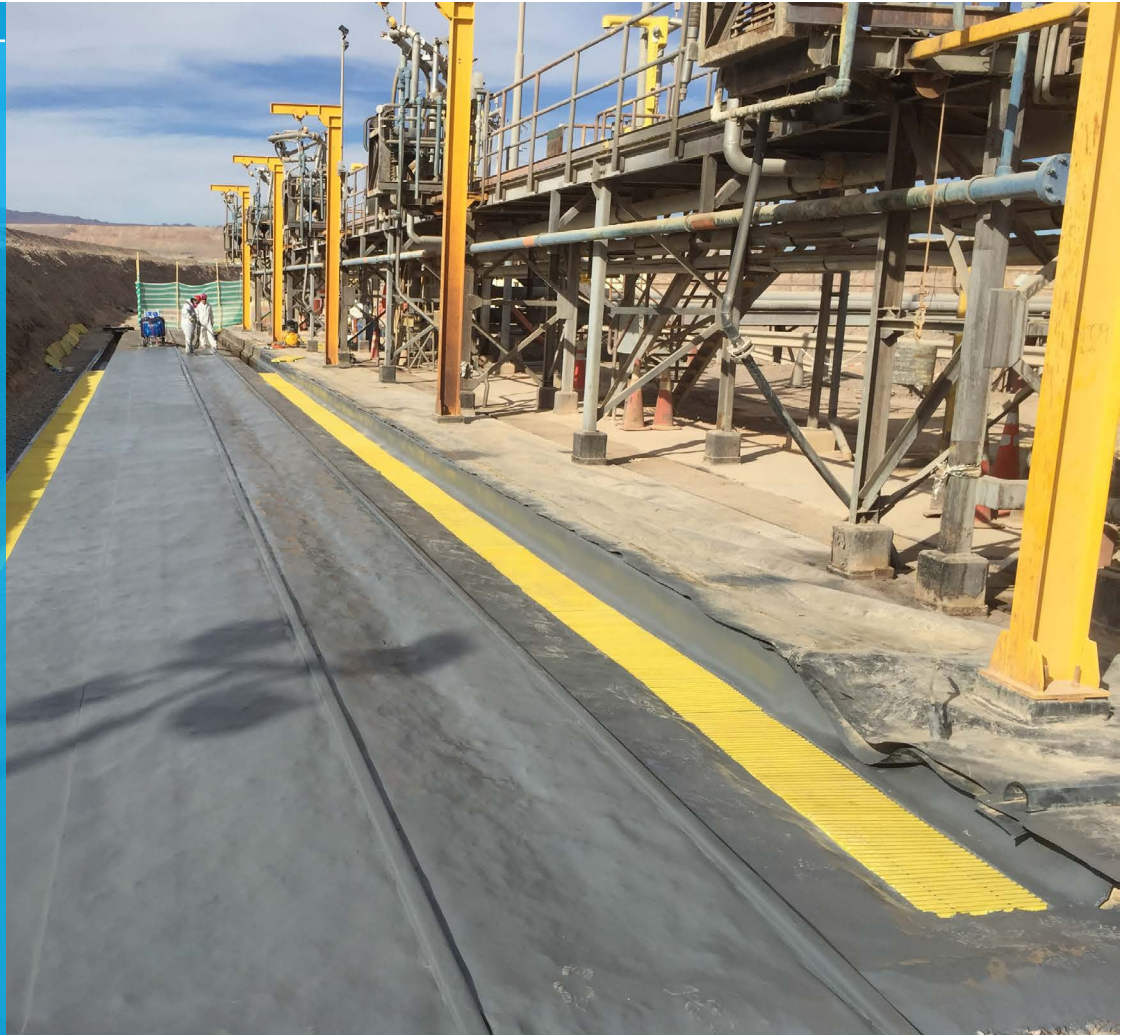
Completed installation

In June 2015, Concrete Canvas® GCCM* (CC) was used as an acid barrier to direct water contaminated with sulphuric acid to holding pits. Train carriages that have been used to transport sulphuric acid are required to be washed down after every use, and the runoff from this process is contaminated with sulphuric acid and is therefore a risk to the environment. Concrete slabs were considered for the project, however these would likely crack due to the vibrations from the trains travelling over them, which in turn would crack the polyuria liner that was specified as the primary barrier measure. Additionally only 3 weeks had been allocated for construction and it would not have been possible to complete a conventional concrete installation within this time.

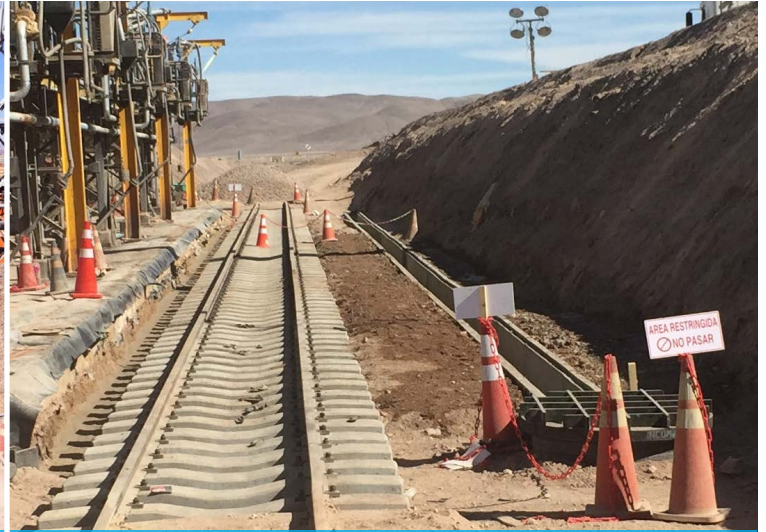
First pre-cast concrete ditch installed

To prepare the site two pre-cast concrete ditches were installed either side of the track, and the track ballast was re-graded to direct the contaminated runoff into the ditches. A blinding layer was then applied to prevent any sharp or protruding rocks from piercing the material or the polyuria layer.

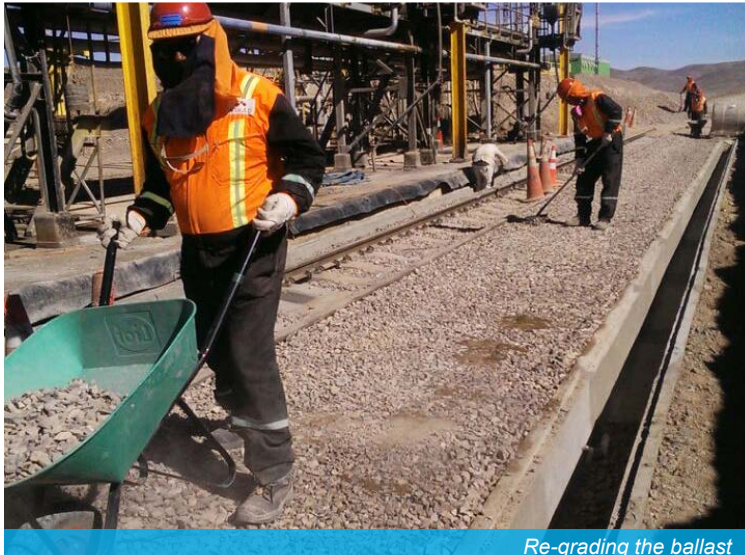
Re-grading the ballast

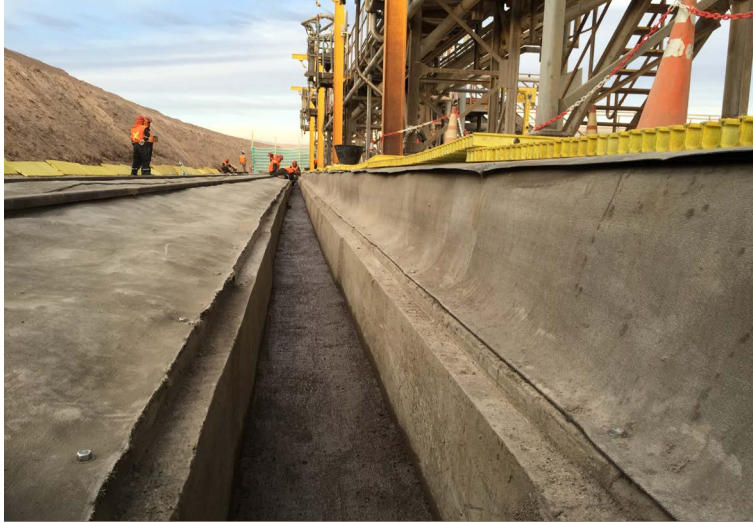
CC screwed to pre-cast concrete ditch

Bulk rolls of 8mm thick CC (CC8™) were delivered to site and mounted onto a spreader beam and unrolled along the track. Where any joints occurred the material was overlapped by 100mm, the CC under the overlap was hydrated and a bead of adhesive sealant was used to joint the material. Masonry screws were used to fix the CC to the pre-cast concrete ditch and the material was fully hydrated using a hose with spray nozzle attached. Once the CC was set, a layer of polyuria was spray applied.

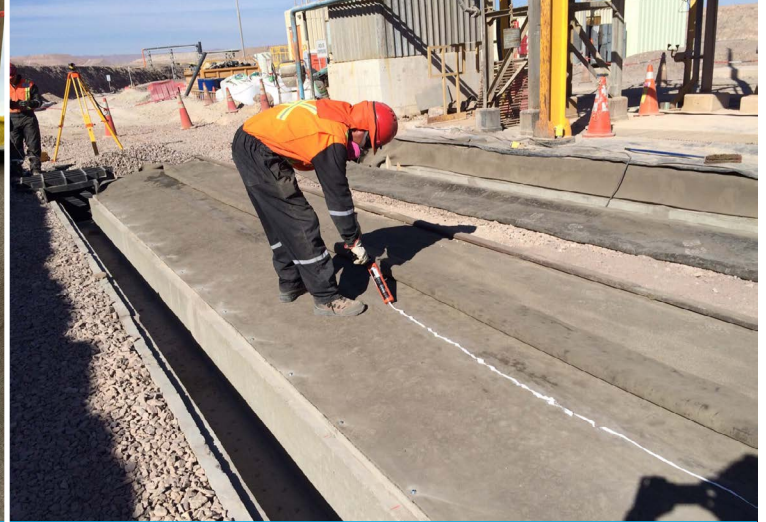
Sealing the overlaps

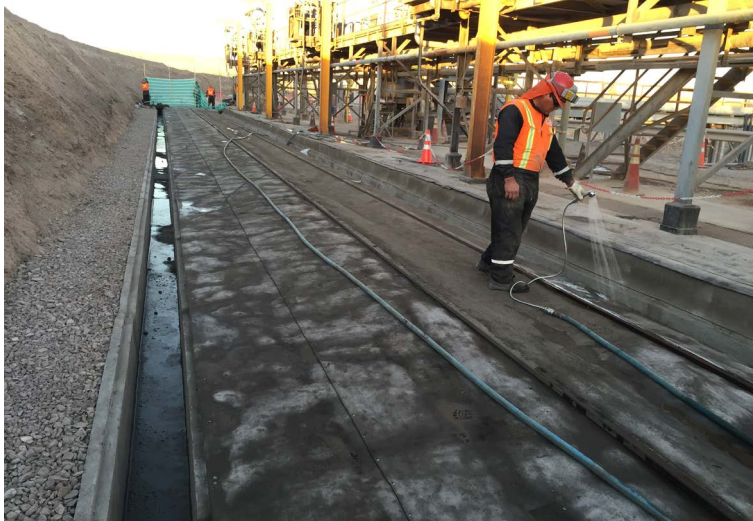
Hydrating the CC

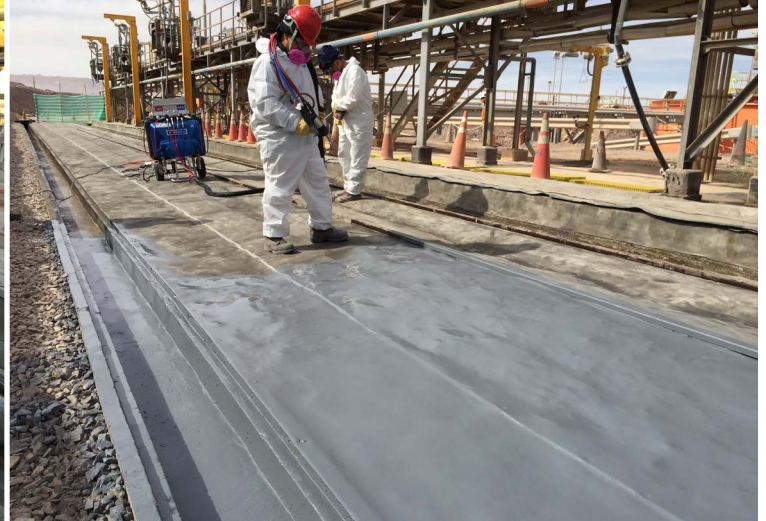
Applying the polyuria layer

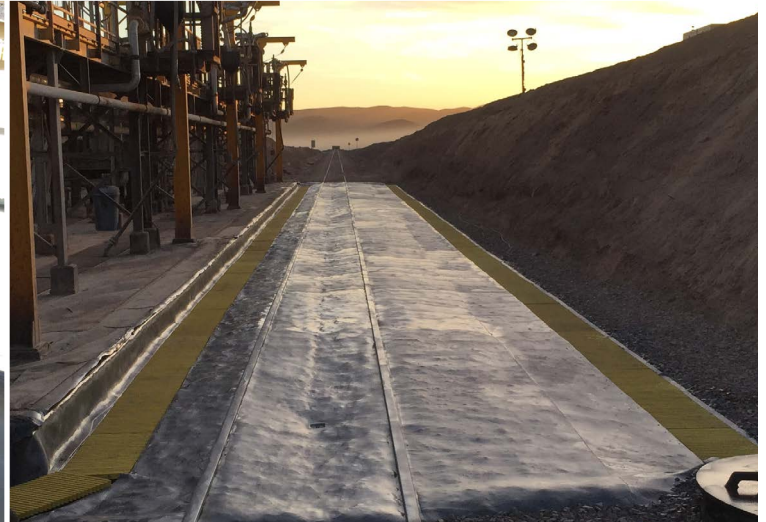
The finished project

In total, 250sqm of CC were installed in less than 20 hours, with only 3 days needed for the entire installation including polyuria lining, instead of the 3 weeks allowed. The client was extremely pleased with the speed of install and has already specified CC for use on another project.
