CC5™ and CC8™ Bulk Rolls

Pogo Mine, Alaska, USA

CC5™ and CC8™ used to remediate a dilapidated shotcrete drainage ditch

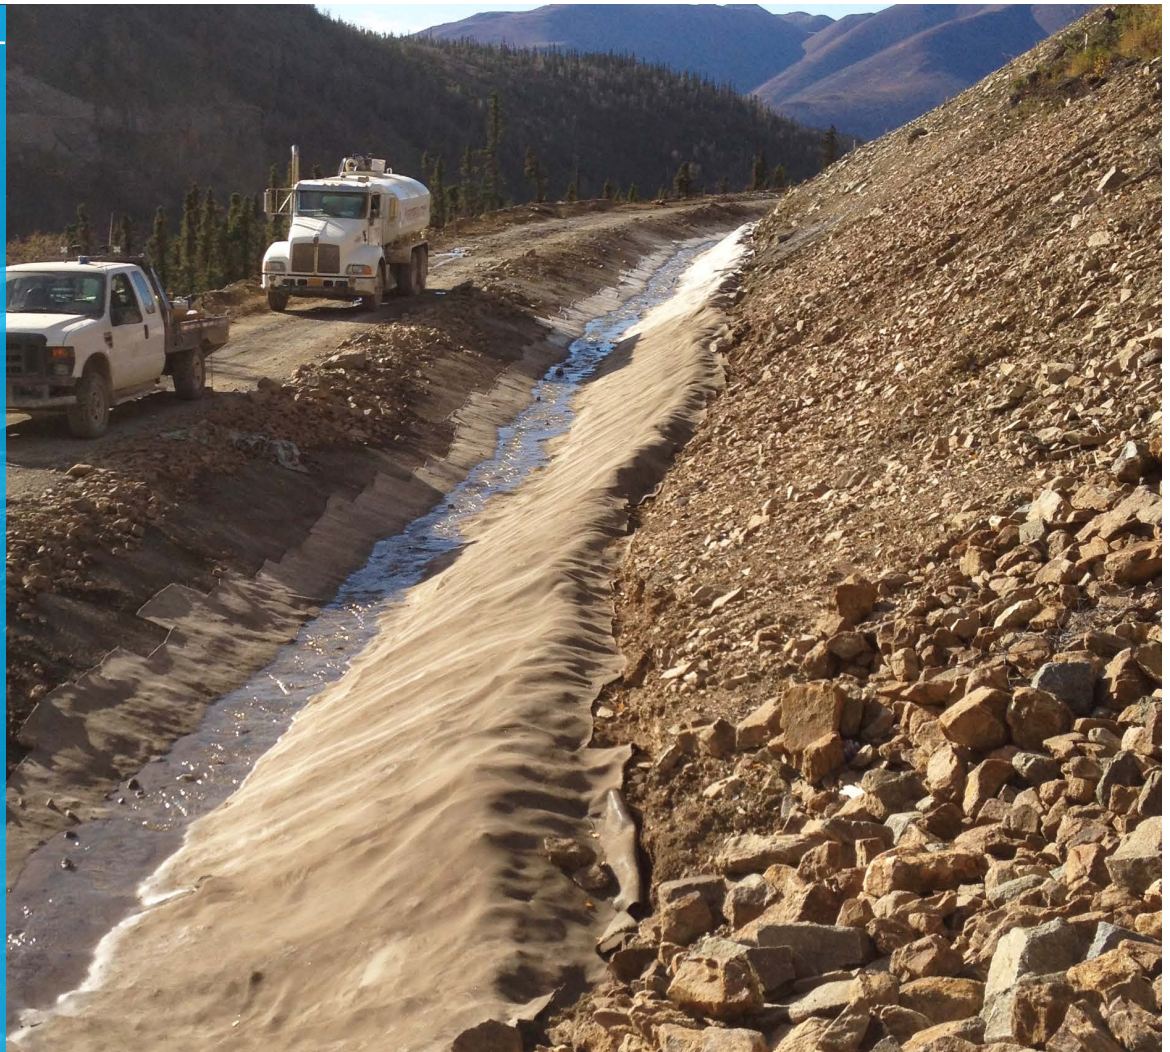
Completed section of ditch

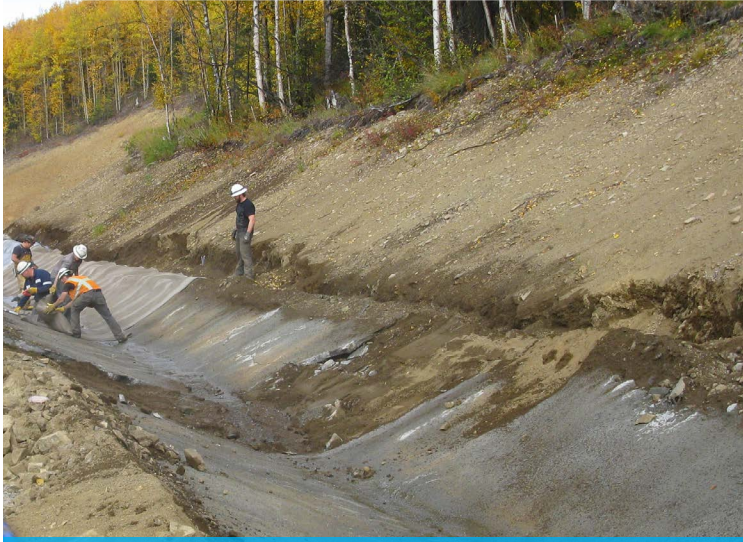
Re-lining the ditch with shotcrete was considered, however 2 miles of shotcrete lined ditches had been installed in the previous two years and proved this was not a long term solution. Storm water had undermined the ditch which, when coupled with freeze-thaw weathering and heavy spring rains, had caused extensive cracking of the shotcrete leading to failure.

Slope causing the runoff undermining the shotcrete ditch

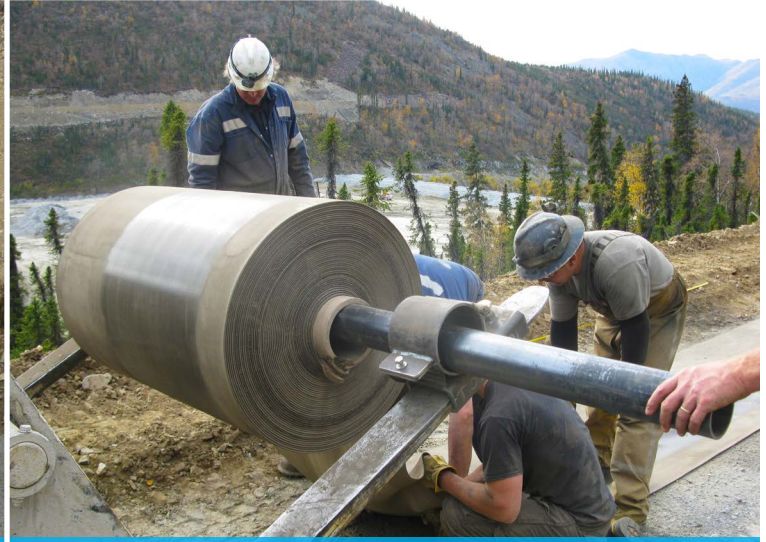
CC mounted to Caterpillar small wheel loader

The CC was mounted onto a Caterpillar small wheel loader with a spreader beam, unrolled and cut to specific profile length with a utility knife to avoid wastage. The mine staff then laid the CC transversely, overlapping layers in the direction of water flow. The outer edges on the side adjacent to the slope were fixed with 305mm Galvanized Ardox spikes into the previously created anchor trench. The overlaps were screwed every 300mm with 20mm truss head stainless steel full thread screws. The roadside edge of the CC was then sealed with a bead of Sikaflex 1A and fixed into the existing shotcrete liner with 15mm x 10mm steel mushroom anchors. The material was hydrated via a water truck with a 50mm adjustable nozzle.

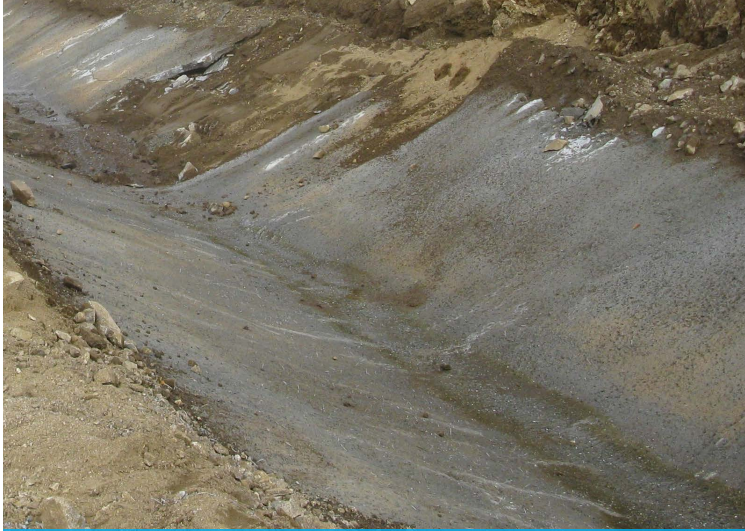
Existing shotcrete ditch

33 Bulk rolls of CC5™ and 5 bulk rolls of CC8™ were delivered to Pogo Mine. The existing shotcrete ditch was cleaned of debris such as rock and vegetation to ensure intimate contact between the CC and the incumbent shotcrete lining. An anchor trench was created at the crest of the ditch adjacent to the slope, above the level of the existing shotcrete, to prevent runoff water from the slope infiltrating under the CC. The opposite side of the ditch is located next to a road, for which the bank was graded and the ditch was re-profiled using a Volvo EC360C and a Caterpillar 320C excavator.

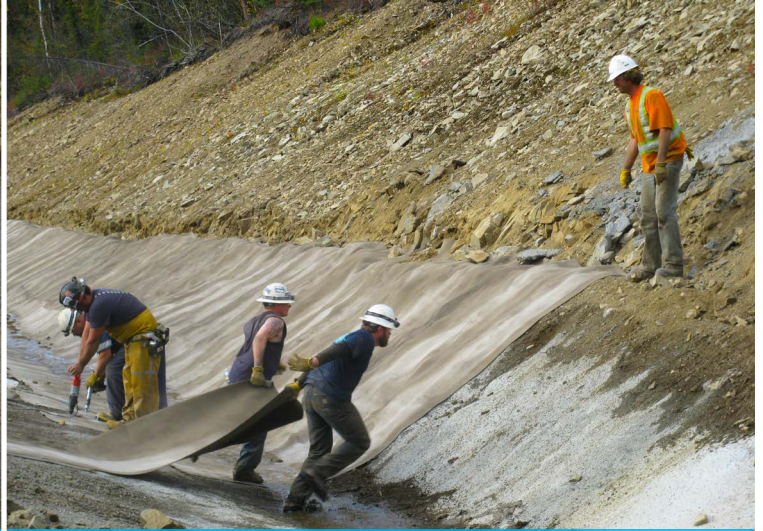
Unrolling the CC5™

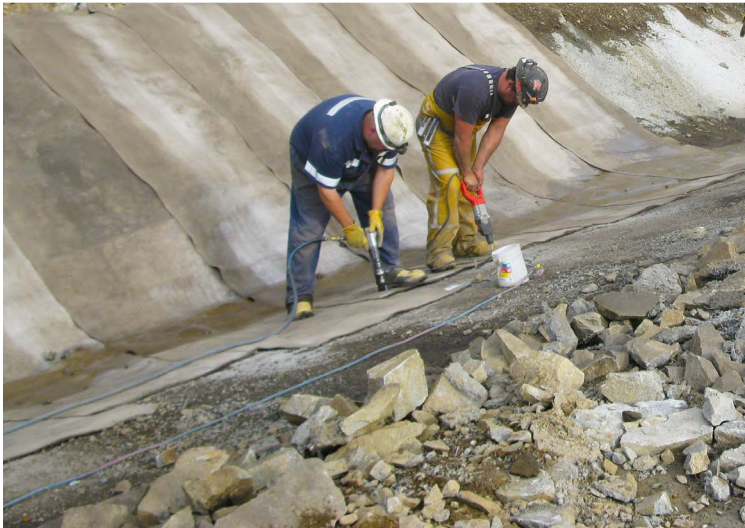
Fixing the CC to the existing shotcrete

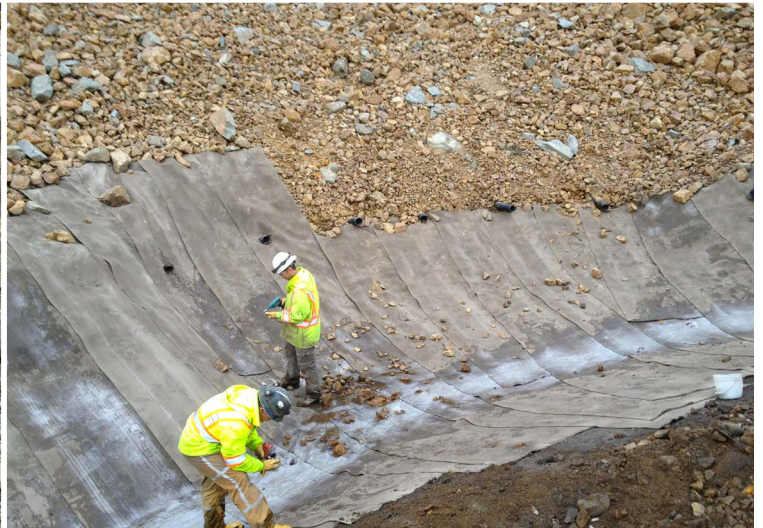
Joining the CC overlaps

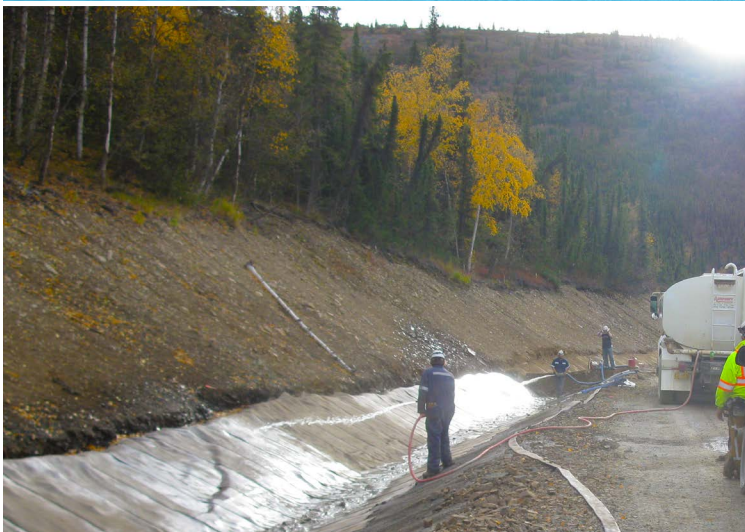
Hydration

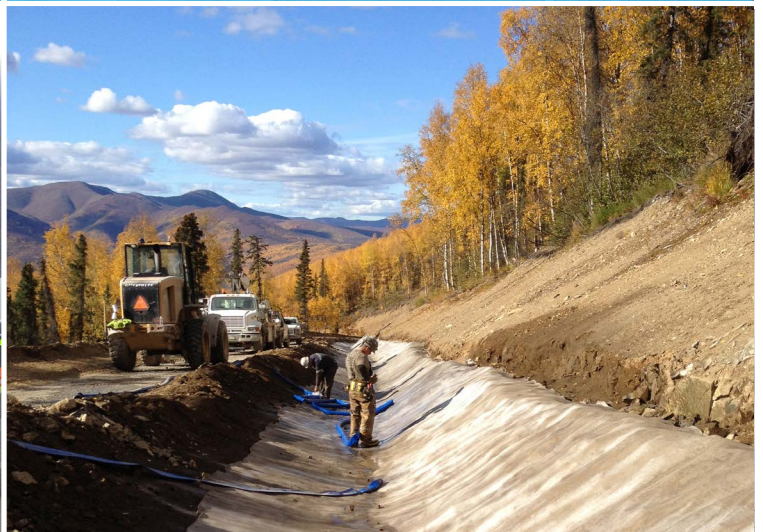
CC post hydration

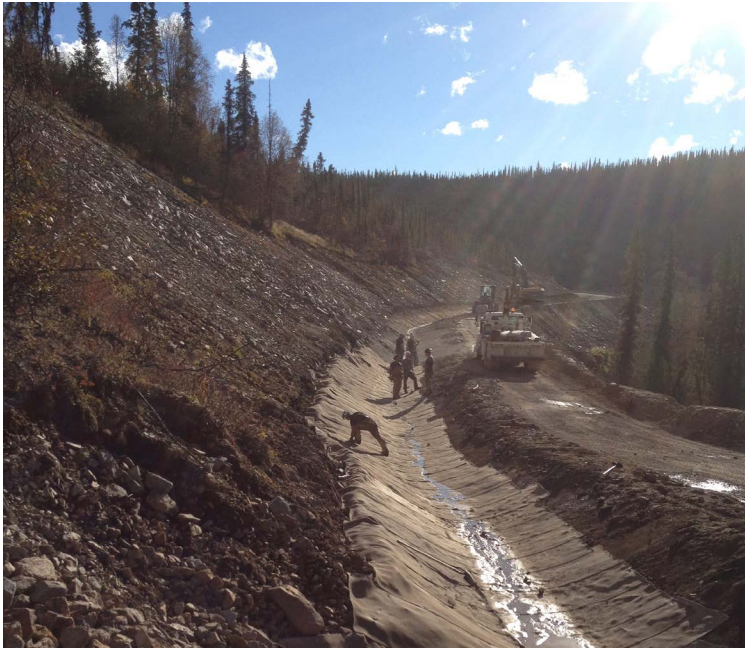
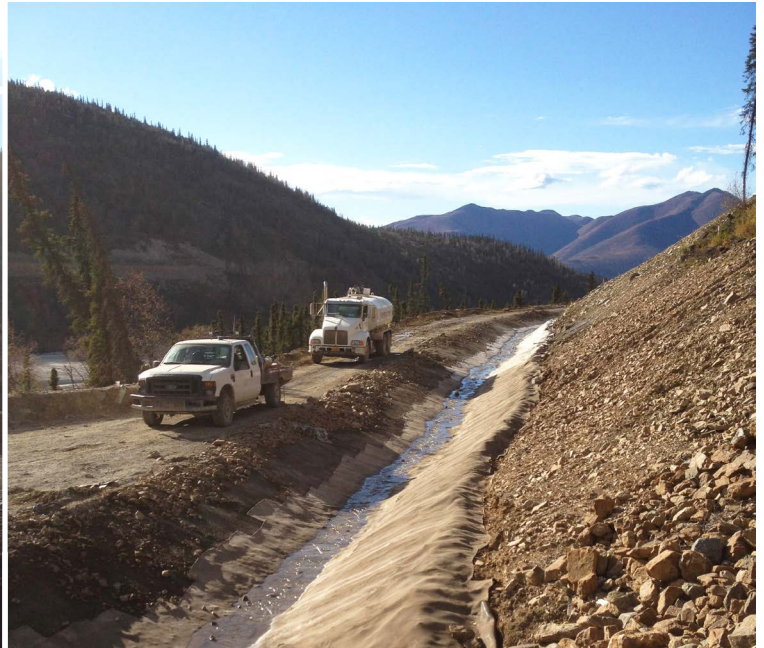
A section of the completed ditch

The 7225 of CC was installed in 11 days at rate of up to 1000sqm a day by a team of 6, in low temperatures. The install was deemed a success due to the speed of install and a huge cost saving of 90%.

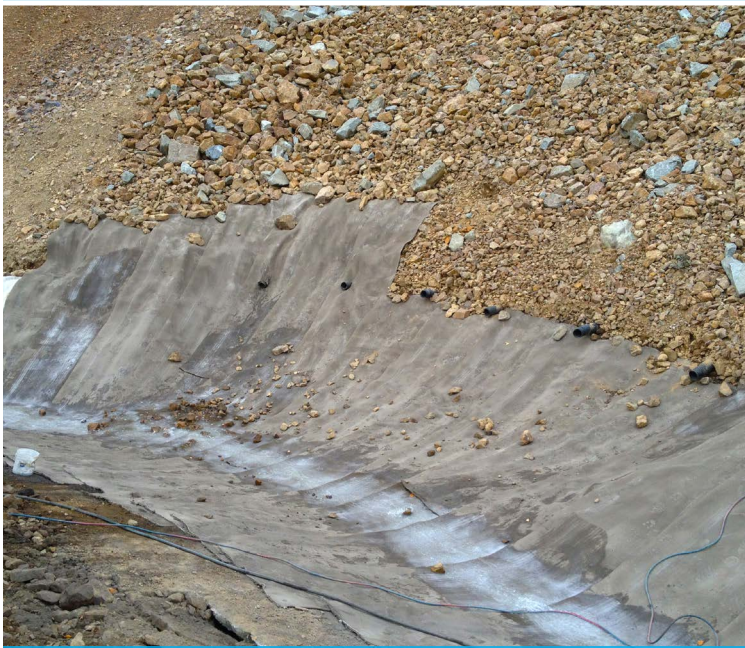
Corner and infrastructure accommodation

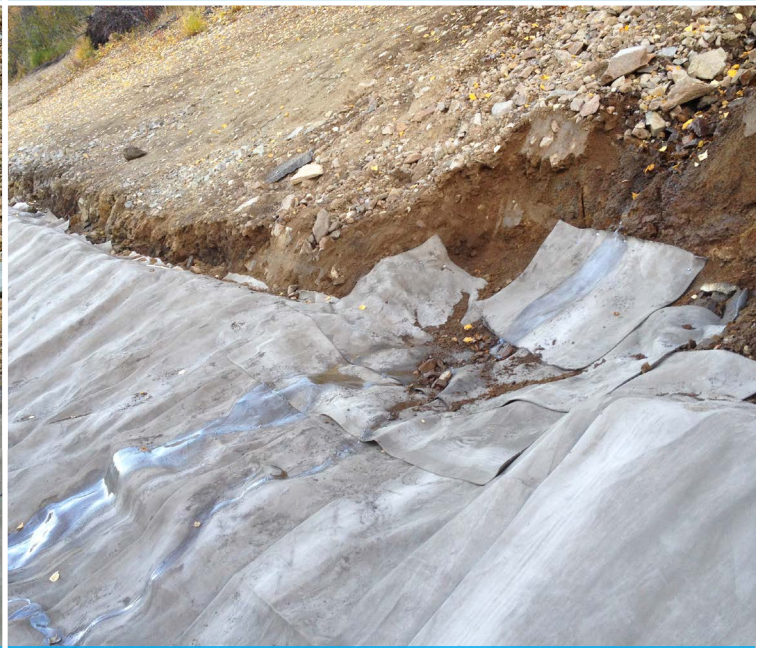
Water inlet
