CC8™ Bulk Roll

Porirua, Wellington, New Zealand

CC8™ used remediate a culvert to eliminate washout

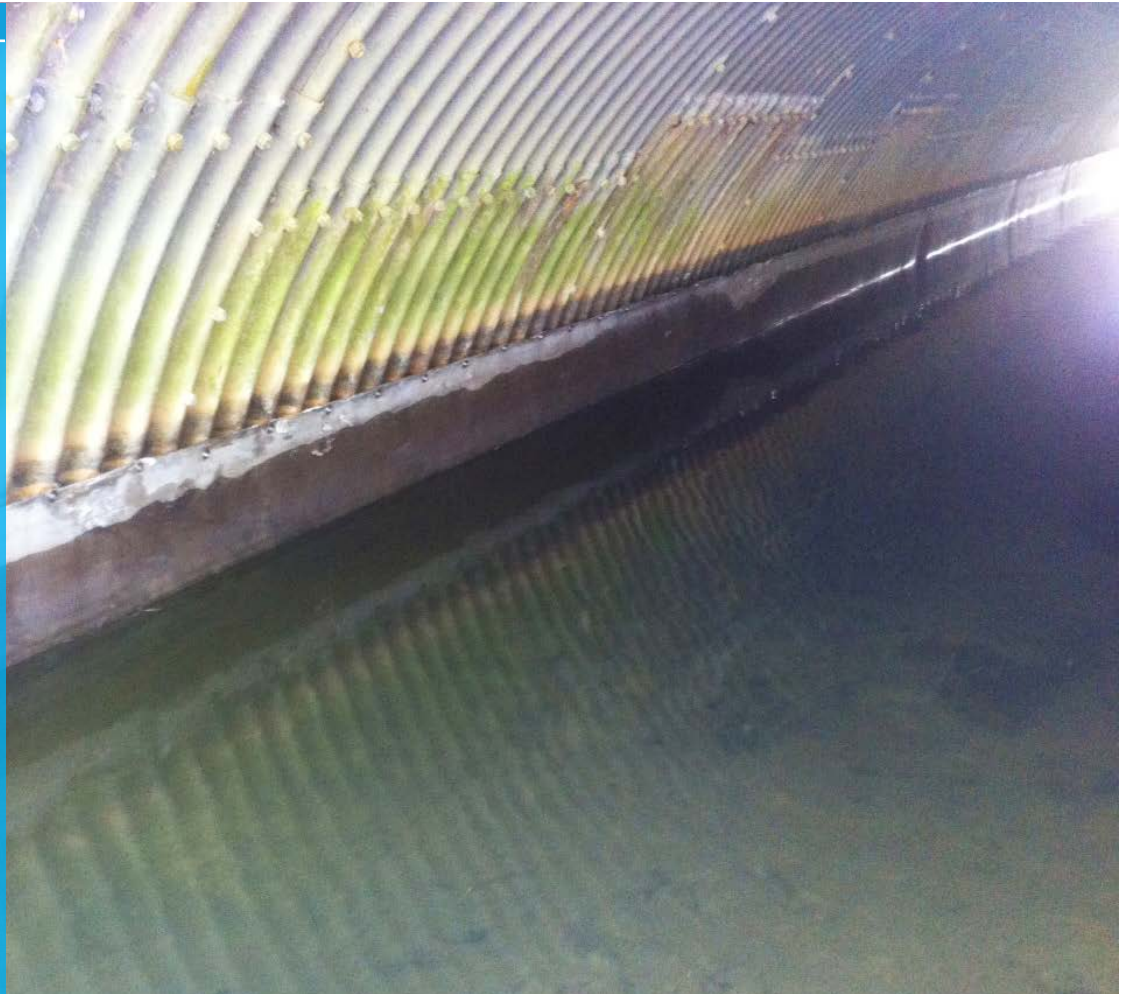
The completed project

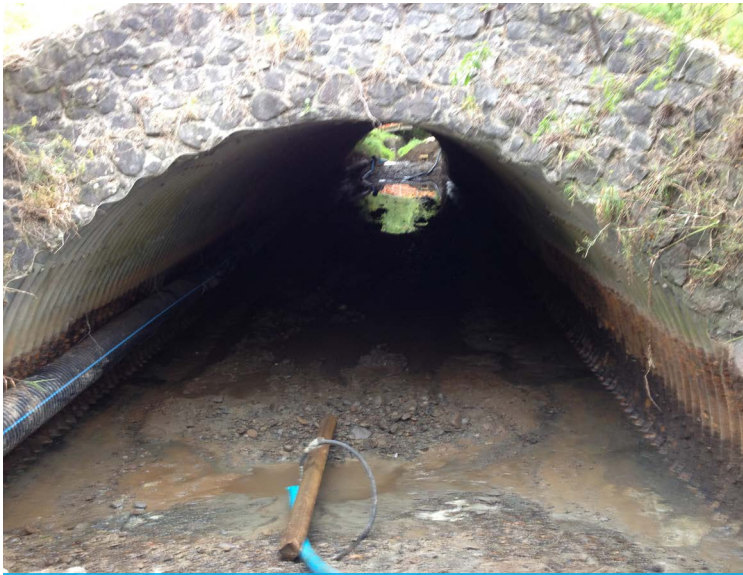
The culvert before work began

In March 2014, Concrete Canvas® GCCM* (CC) was specified to remediate a culvert in Porirua, Wellington, New Zealand. The client was Porirua City Council and the installation was completed by Rasmax. Concrete Canvas® GCCM was selected due to the culvert being difficult to access, the installation speed and the cost effectiveness of CC. Sprayed concrete was considered, but the damp and cold conditions combined with the bed being lined with sediment would have made it exceptionally difficult to use this method.

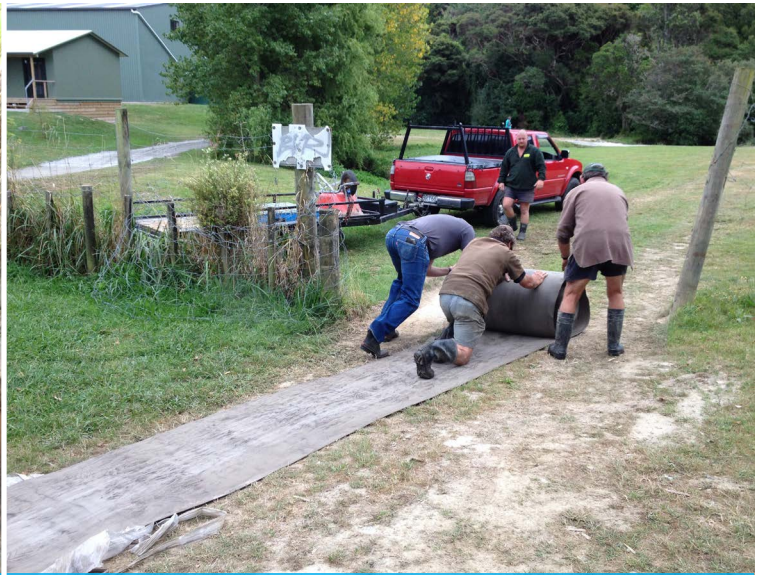
Unrolling the CC8™ to cut it to length

To prepare the site, the drain was cleared and the area dammed with the flow diverted. A bespoke length was cut from a bulk roll of 8mm thick CC (CC8™) and delivered to site. This was then unrolled on the flat and cut to length, before being carried into the culvert. The CC8™ was fixed to the existing corrugated metal using 32mm hex self drilling screws at 200mm centres. Where CC8™ joints were needed, overlaps of 100mm were created and mechanically jointed with more hex screws. For hydration the CC8™ was submerged in water once work was completed.

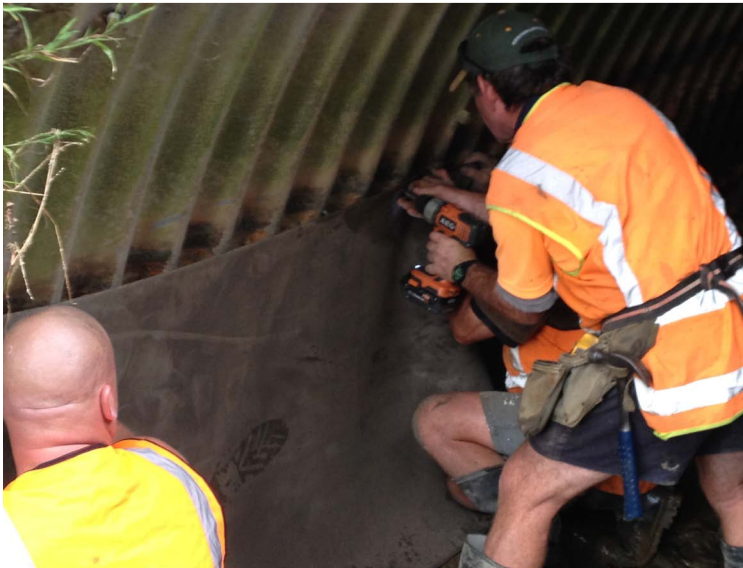
Fixing

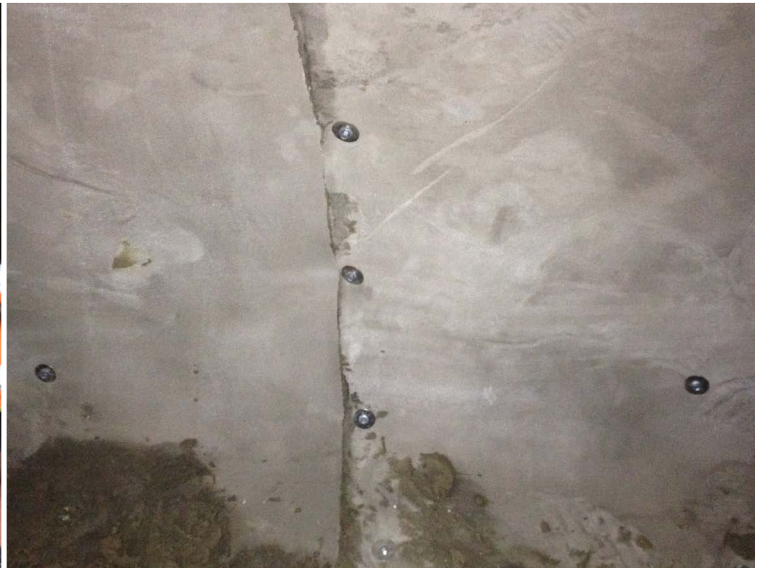
32mm hex screws

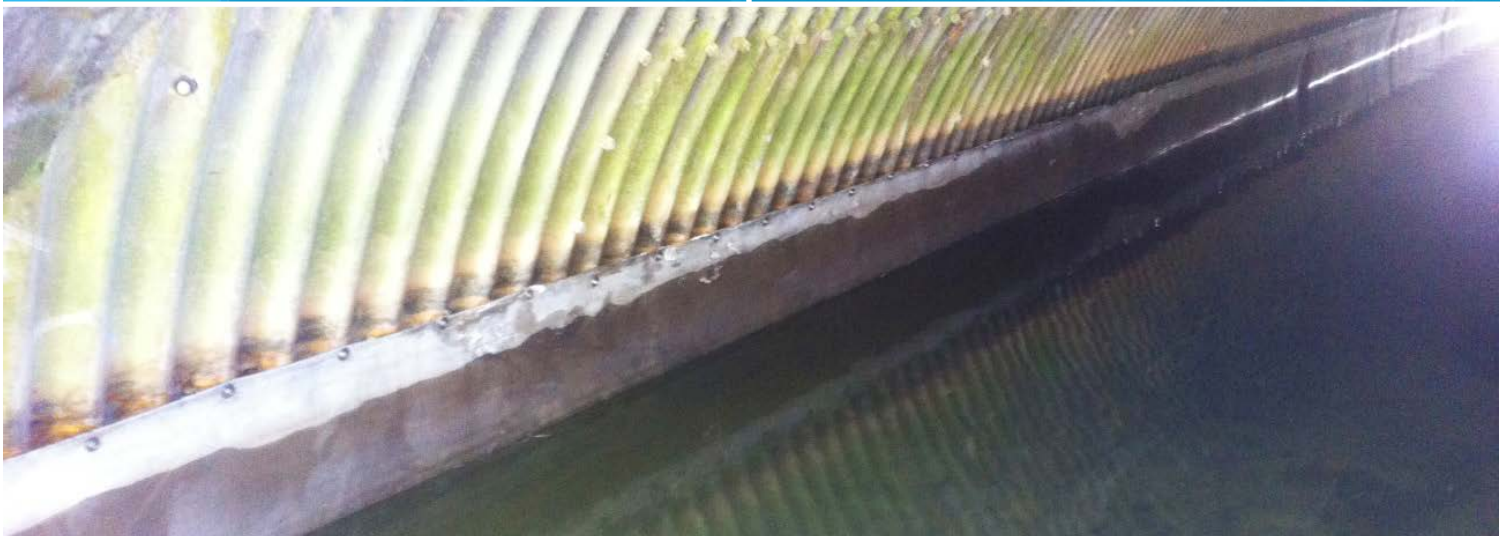
The finished project

In total 80sqm of CC8™ were installed by 3 people in just 6 hours (with 8 hours of site preparation) when the client had allowed for 2 days. Furthermore CC's low alkalinity and low wash out rate meant the works did not negatively impact the local ecology.
