Thames, New Zealand

Thames Coromandel District Council, Transfield Services

CC8™ used to remediate a concrete curb and drainage channel

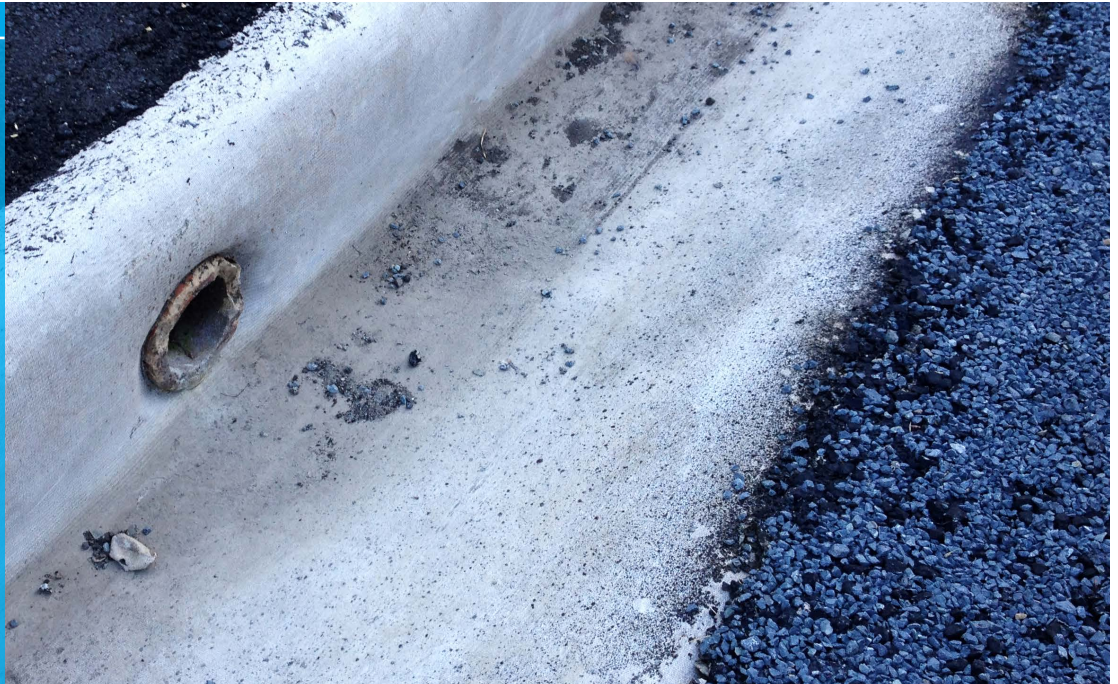
Completed curb

Installation was carried out by Thames Coromandel District Council, Transfield Services. Prior to the installation of 8mm thick CC (CC8™), loose rock and debris were removed from the old concrete ditch and anchor trenches were created on either side by removing soil and a small section of tarmac. A bespoke length of CC8™ was cut from a bulk roll, delivered to site and unrolled along the length of the ditch by hand, with a hole being cut for an existing pipe. 50mm nails were used to fix the CC8™ to the substrate before it was hydrated using sprayed water from a water tank. The anchor trenches were then backfilled using chip seal on one side and holt mix on the other. The edges around the drain were treated with epoxy to create a water tight seal.

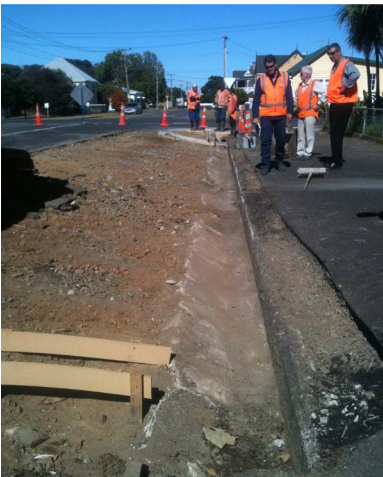
Original concrete curb

In February 2014, Concrete Canvas® GCCM* (CC) was used to remediate a damaged curb and channel in Thames, New Zealand. The original poured concrete ditch was cracking due to age and environmental weathering.

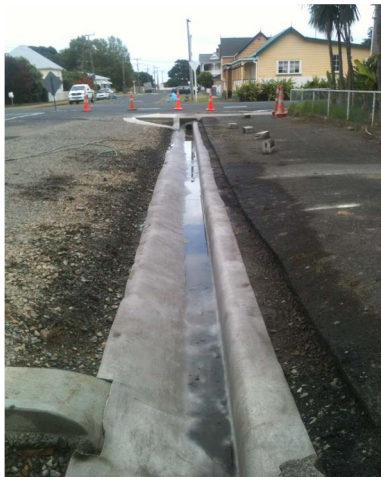
After hydration

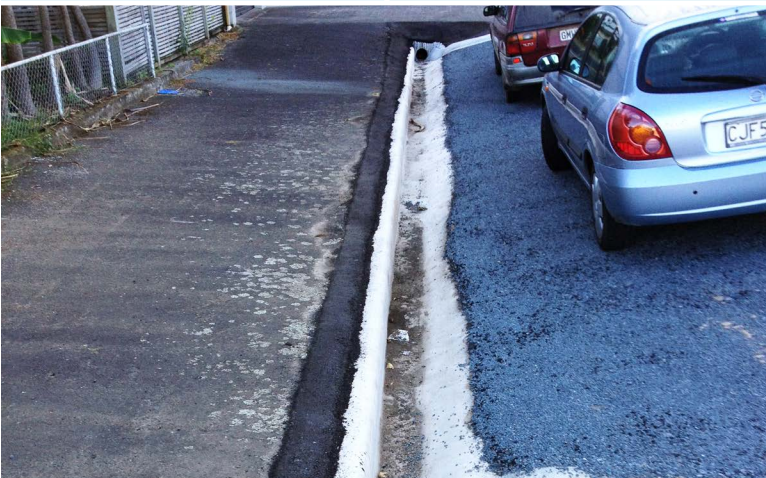
The finished curb

The project was installed by a team of 3 in 1 hour, which was **an estimated 5 times faster than poured concrete**. The client was pleased with the CC8™, especially the speed and ease of install, as well as cost effectiveness. **The council will likely use Concrete Canvas® GCCM in future projects.**
