SEALGRID N11, Section 2, KZN Pavement Rehabilitation

Case Study

PROJECT: N11 Section 2, Ladysmith South IC – km 0,0 to Nkunzi River Bridge – km 47,75, KZN
CLIENT: SANRAL
DATE: Jan 2003 – June 2004
CONSULTANT: Ingerop Africa and Nankhoo & Associates JV
PRODUCT: GlasGrid® 8501, Sealmac®, Sealgrid
CONTRACTOR: Road Mac Surfacing [Pty] Limited
TRAFFIC: 6 000 vpd (20%)

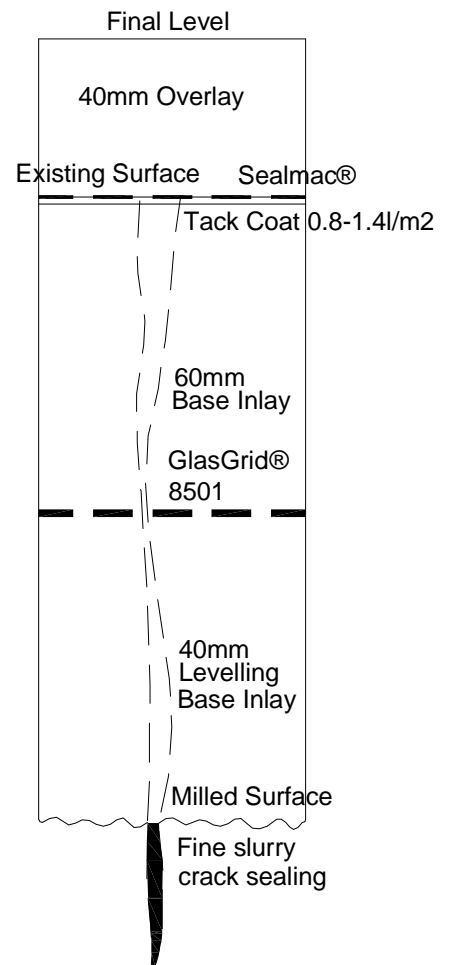
Km 42 946 – **GlasGrid® 8501** installation, 2003

GlasGrid® was specified as a specialised method of repair where severe cracking and surface deformation were evident. The top 100 mm asphalt was milled out and visible cracks sealed with a fine slurry. A 40 mm asphalt levelling course was then placed and **GlasGrid® 8501** (100 x 100 kN/m) installed and overlaid with 60 mm base course asphalt

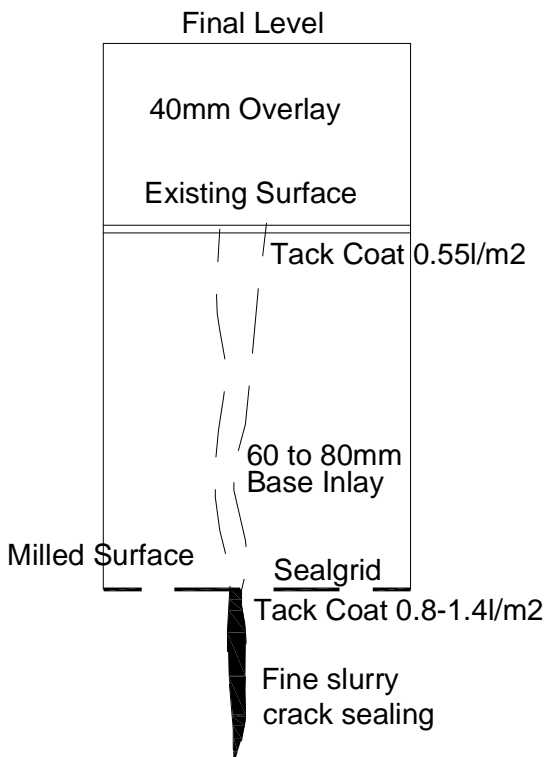
Km 32.200 – **Sealgrid** installation, 2003

REPAIRS IN AREAS WHERE DEEP MILLING WAS NOT JUSTIFIED
Sealgrid® 50 kN by 50 kN was installed in situations where the severity and depth of cracking over non-deformed areas were such that milling to 100 mm depth was not justified or practicable. 60 mm to 80 mm asphalt was milled out and residual cracks filled with a fine slurry. A tack of CAT60 coat bitumen emulsion was applied at 0.8 to 1.4 l/m² and **Sealgrid®** installed. Base course asphalt was inlayed to the existing level and overlaid with 40 mm premix.

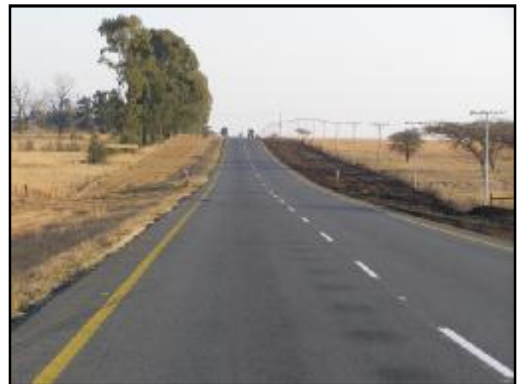
Km 32.200 – **Sealgrid** performance, July 2008. Note cracks have not reappeared
