Drainage Road Maintenance N3 between Estcourt & Frere

Case Study

Project: Special Maintenance on N3
Client: N3 Toll Concession
Consultant: WSP Civil & Structural Engineers
Contractor: Kevin Pickard Projects

Date: June 2011
Product: **Megaflo™ 300**
Quantity: 10 400 m

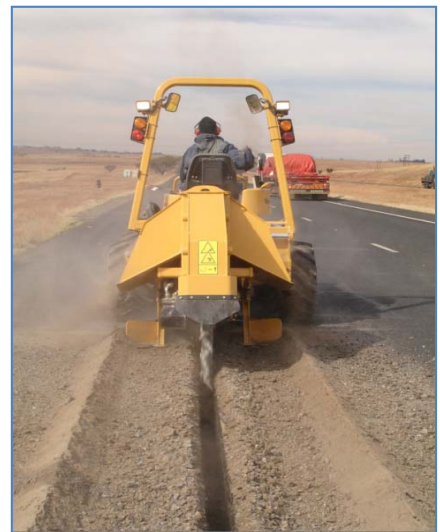
Rock saw digging the trench

A rock-saw was used to dig a 450 mm deep trench between the shoulder and the slow lane of the designated stretch of highway.

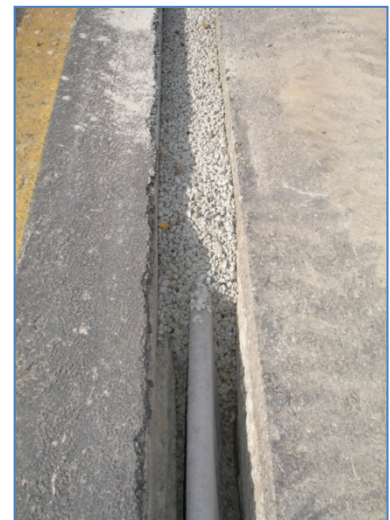
***Megaflo™** installed with backfill*

Once **Megaflo™** was installed, the trench was backfilled with a 9 mm no fines concrete and finished off with an asphalt plug. A strip of **Sealtac™** was then applied to act as a moisture barrier. The system now allows the layer works to drain to a depth of 450 mm.

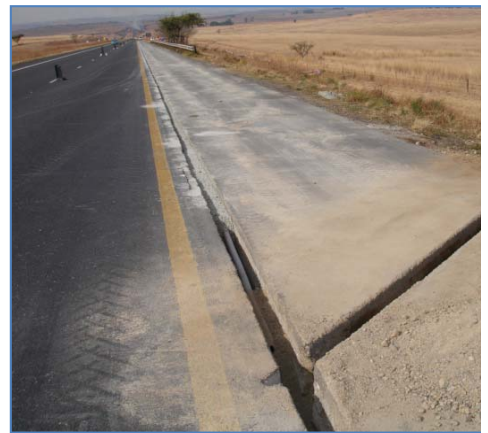
Section of N3 with before final asphalt layer applied
