## Roads Maintenance Drainage N2 Van Stadens – St Albans, Eastern Cape

### Case Study

<b>Project:</b>	N2 Section 10 – 11, Van Stadens River to St Albans Int.	<b>Date:</b>	March 2010
<b>Client:</b>	SANRAL	<b>Product:</b>	<b>Flo-Drain, Geopipe</b>
<b>Consultant:</b>	Stemele Bosch Africa (Pty) Ltd	<b>Quantity:</b>	14 000 m <sup>2</sup>
<b>Contractor:</b>	Concor Roads and Earthworks	<b>Rep:</b>	Julian Maastrecht

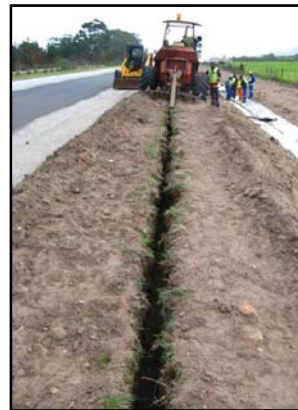
*Digging the narrow trench*

A full soil grading was obtained from tests of the in situ soils and analysis done on geotextile compatibility and flow capacity to assist the contractor with acceptance of the proposed **Flo-Drain** alternative. The permeability calculated was > 10 times that of the in situ soil. A check was done on transmissivity of the **Flo-Drain** and the infiltration and carrying capacity of **Geopipe** and found to be adequate. 90% passes 2 mm sieve, providing a large factor of safety against installation damage and providing the contractor opportunity to use narrow-width trenching equipment. A hydraulically compacted coarse river sand was used to backfill the trench.

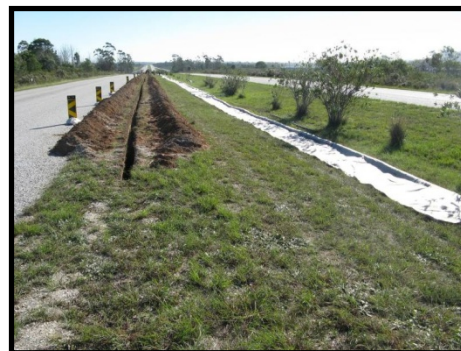
*Flo-Drain ready for installing*

**Flo-Drain** was offered as an alternative providing a 10% cost saving. 12 000 m **Flo-Drain** 1000 and 2 000 m **Flo-Drain** 1650 were installed along the shoulder on the median and edge of the road where required.

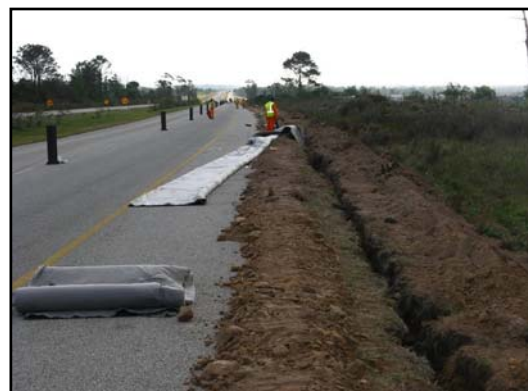
*Installation of Flo-Drain into the ditch before being backfilled with river sand*
