## CASE STUDY

Drainage | Reservoir Leak Detection | Annlin Reservoir, Pretoria

Sep 2012

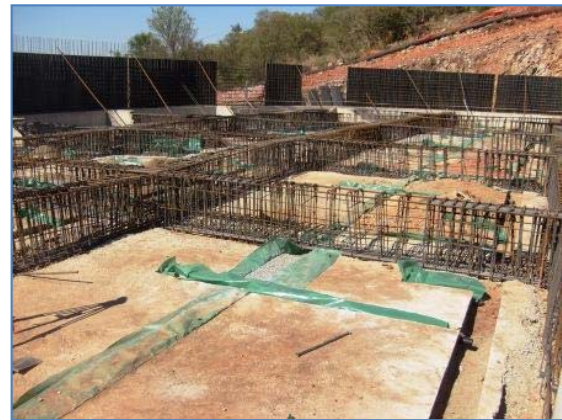
*The grid system for leak detection*

In order to simplify the search for any future leak, the floor was compartmentalised into a grid system covering the area of the reservoir. Through different coloured pipes, each section of the grid would feed into a manhole constructed on the side of the reservoir. With each section of grid being represented by a particular colour, a leak would be easily and accurately detected. **Flo-Pipe<sup>®</sup>** wrapped in **bidim<sup>®</sup>** was placed into the trenches of the reservoir floor and covered with no-fines concrete. These trenches will then drain any leaked water into the adjacent manhole. The wrapping of **bidim<sup>®</sup>** around the **Flo-Pipe<sup>®</sup>**, primarily serves a filtration function and secondarily to separate soils.

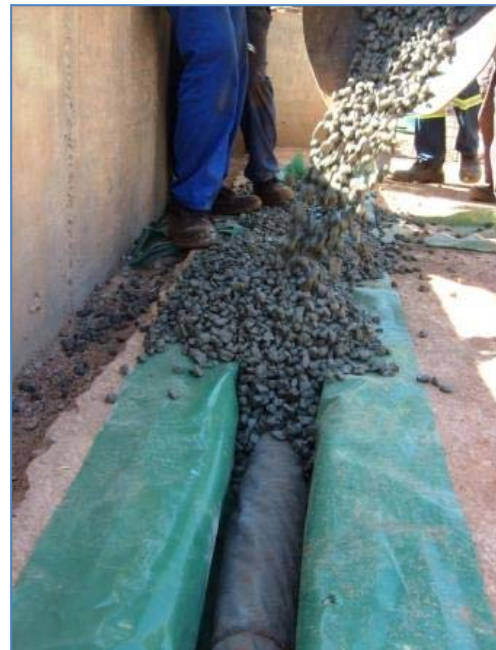
*The **bidim<sup>®</sup>**-wrapped **Flo-Pipe<sup>®</sup>** is covered with no fines concrete*
