CASE STUDY

Erosion Control | Landfill Slope | New England Road Landfill, Pietermaritzburg

Oct 2012

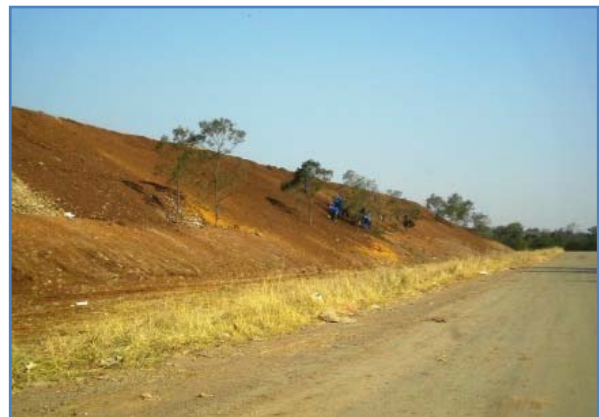
Topsoil on the slopes of a landfill site alongside New England Road, Pietermaritzburg, was being eroded by rain and strong winds resulting in blockage of surface drains at the base of the slopes. This in turn caused excessive surface water build-up with subsequent damage to site infrastructure while the resultant run-off was polluting the nearby Msunduzi River.

Exposed slope

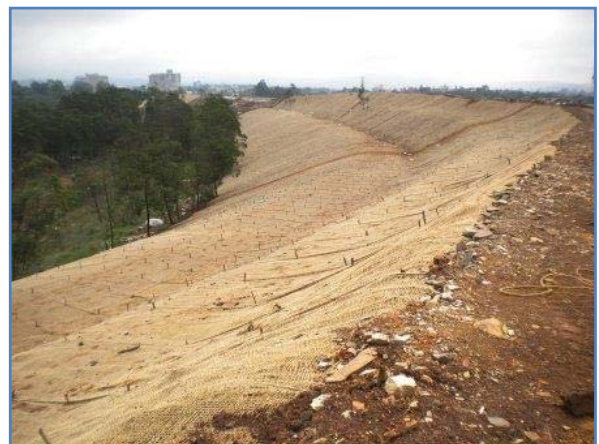
*Slope with **SoilSaver®** jute pegged to surface*

Envitech Solutions specified **SoilSaver®** as the single solution to the destructive, costly chain of events. Although an alternative to using **SoilSaver®** in this project might have been hydro seeding directly onto the slopes, the first rainfall would have resulted in seeds being washed down to the base and the slopes left bare of vegetation. Supplied in lightweight bales, **SoilSaver®** was rolled out and pegged down to the slope to hold seeds & soil firmly in place.
