CASE STUDY

Water Containment | Dam Lining | Quoin Rock Farm, Stellenbosch

Apr 2014

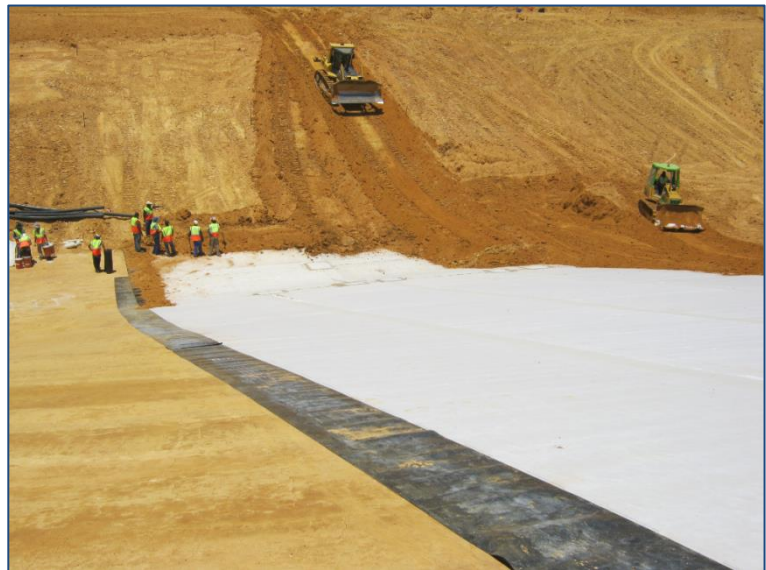
EnviroFix® GCL was easily laid on the steep slope

EnviroFix® GCL was laid onto a well compacted, smooth surface and covered with the recommended minimum cover thickness of 300mm on the floor of the dams, and a 150mm clay cover layer on the slopes of the dams. The additional confinement required on the slopes was made up with a layer of 200-250mm size riprap, placed on top of the GCL/clay lined embankments for protection against erosion and wave action.

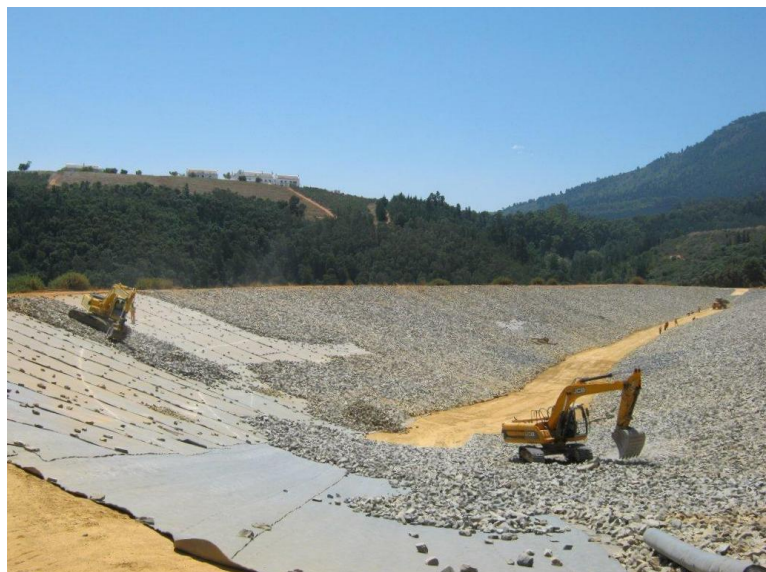
bidim® A8 forms a protection layer with the riprap

Since this angular riprap has sharp edges, **bidim® A8** geotextile was placed beneath it as a protection layer, allowing sufficient retention of soil underneath the riprap.
