## **DEFENDING DURBAN'S BEACHES**

### **Introduction**

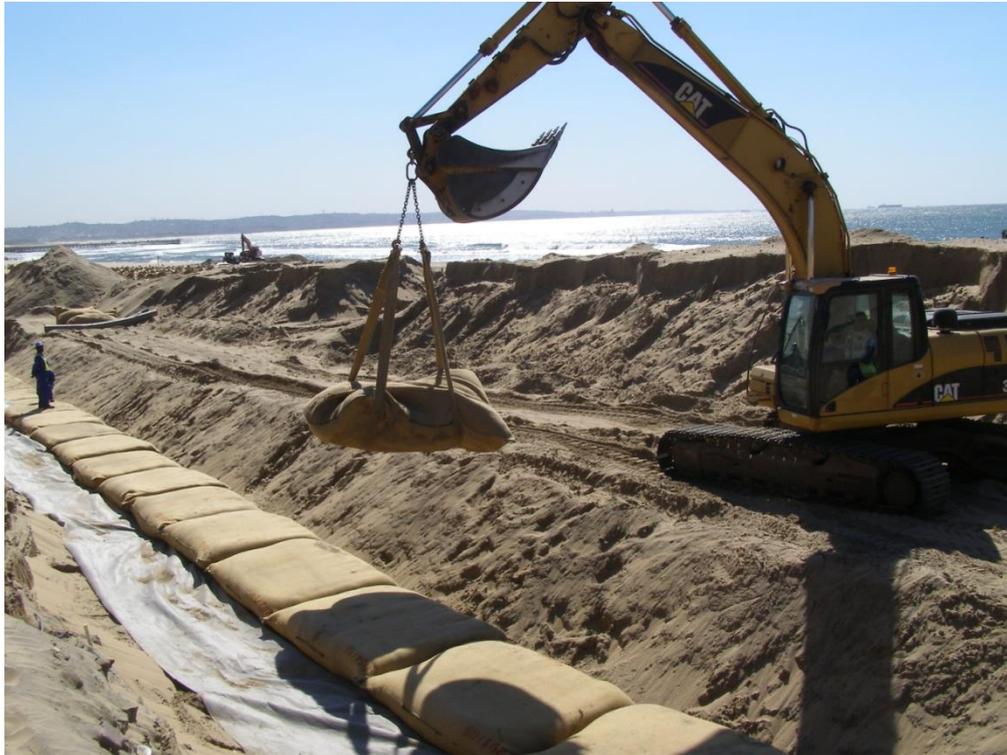
*Placing of EnviroRock™ geocontainers*

The Durban Port Authority frequently dredges the harbour mouth and together with eThekweni uses this sand to replenish the beaches. However the sand that is pumped onto the beach is eventually lost to the sea as the currents move the material up along the coast and back off shore. This second line of defence was to create a seawall using Kaytech's EnviroRock™ geocontainers. These bags provide a temporary holding measure until such time the sand is dredged and pumped back onto the beach and the natural beach profile re-established.

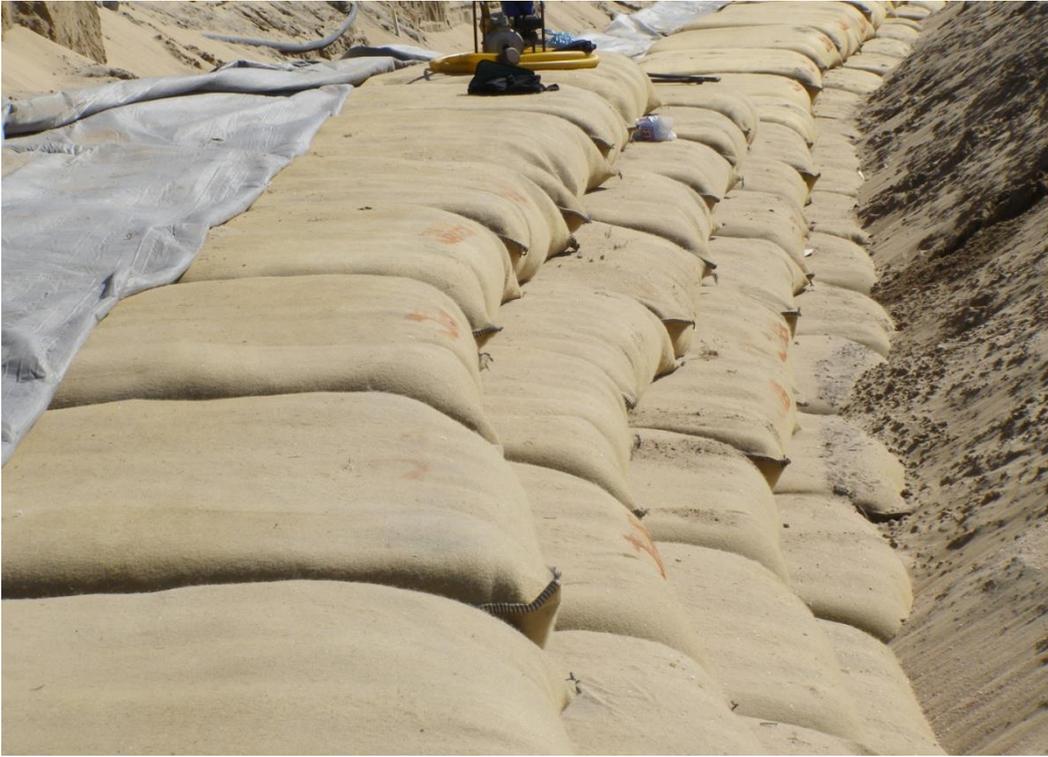
*Double layer EnviroRock™ Wall*

The design detailed the use of 3.5 ton to 4 ton geocontainers. The wall was constructed using a double layer of these containers (i.e. one bag behind the other) for the full height of the protection at a slope of 1:1. In addition, provision was made for a flexible front toe that protrudes out from the main structure, commonly referred to as a "Dutch toe" or "self healing toe" for scour mitigation.

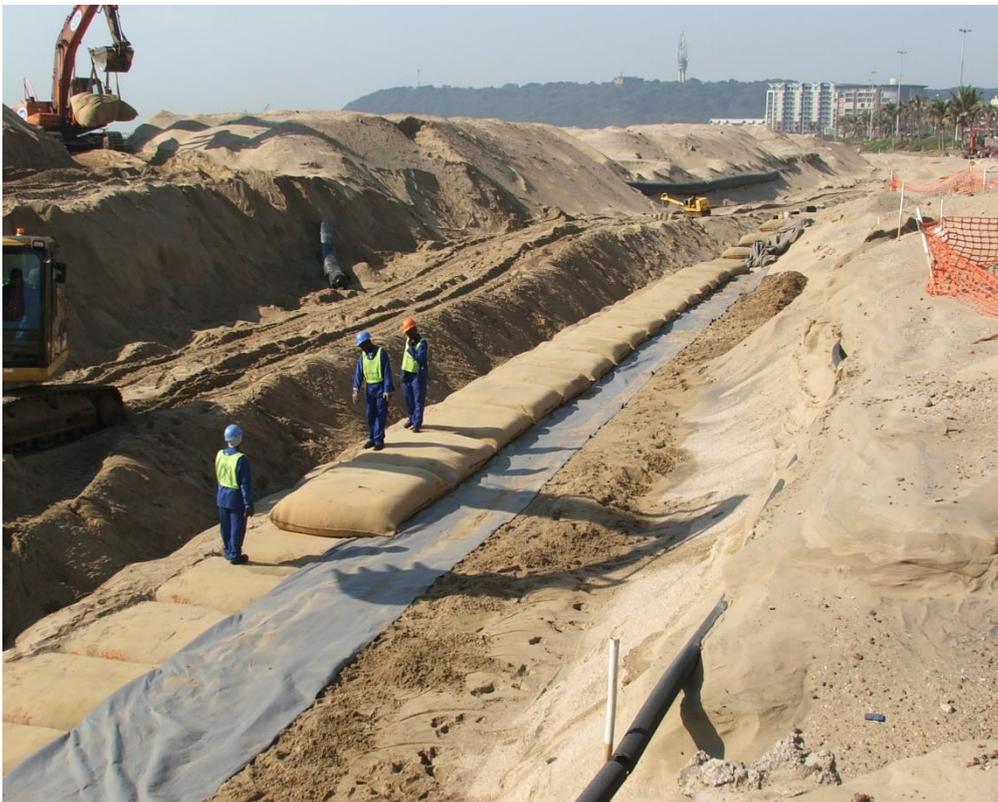
*Single Layer of EnviroRock™ with RockGrid® PC wrap around wall*

The financial constraints of the client had to be considered, therefore, the area immediately in front and some distance either side of buildings was protected with a double layer of geotextiles whilst the remainder of the promenade was protected with a single layer and a two meter high RockGrid® PC 100/100 geogrid wrap around wall.

The geogrid referred to is a high tensile strength composite polyester grid combined with a lightweight needlepunched nonwoven polyester geotextile that provides excellent reinforcing characteristics and ensures minimum deformation in the structure. As a composite reinforcing grid, the geotextile component provides sufficient drainage capacity within its plane, i.e. transmissivity, enabling it to reduce pore pressure build-up in the reinforced soil, thereby improving the internal shear resistance and overall stability of the structure.

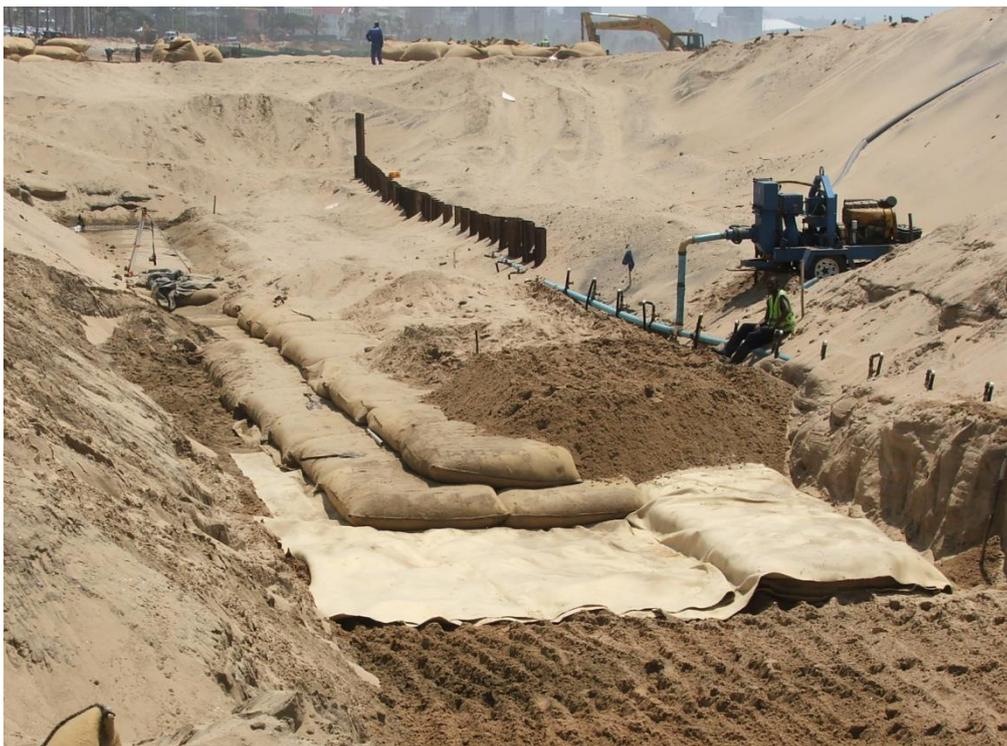
*Installed Section of EnviroRock™ Wall*

EnviroRock<sup>®</sup> geocontainers are specifically designed for the projects where they are used, and manufactured from a robust, durable nonwoven staple-fibre polypropylene material which is UV stabilized and abrasion resistant making it well suited to coastal erosion control applications. The systems, designed with input from Kaytech, are effective, and an aesthetic solution that assimilates well into the environment.
