CASE STUDY

Drainage | Tailings Facility | Sylvania Metals Tailings Facility, Marikana

May 2012

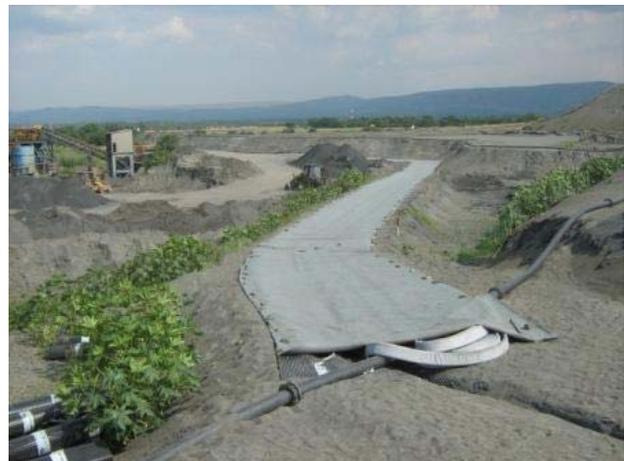
Megaflo®, bidim®, Zipcore®, Kaytape® drainage solution

The area around the dam wall perimeter was first cleared, shaped and then compacted. A central longitudinal groove was then formed into which the **ZipCore®** sheeting was laid and **Megaflo®** pipe placed over.

The **Megaflo®** and **Zipcore®** was then covered with a layer of **Kaytape® S270**, retaining an open flow path above the **Zipcore®**. The Kaytape is followed by a layer of **bidim® A6**, which was tucked underneath the sides of the **ZipCore®**.

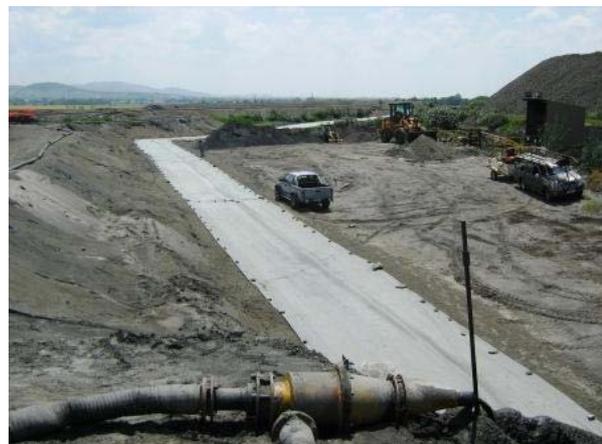
The geosynthetic perimeter drain

cycloned to cover the newly installed drain, extending beyond the drain, and ultimately forms the perimeter wall.

Efficacy of the design is proven by water flowing from the new system into the collector drains, and no sign of water seepage on the dam wall. The cost-saving and ease of application can be carried forward to other tailings facilities.
