CASE STUDY

Drainage & Filtration | Road Rehabilitation & Maintenance | N1 Pienaarsrivier to Bela Bela

July 2015

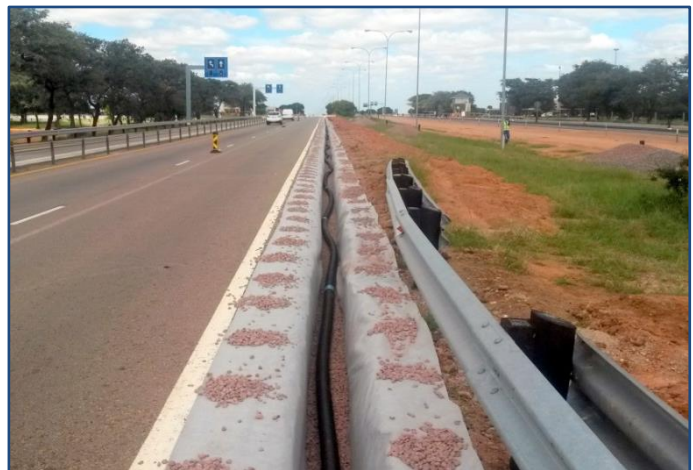
Certain sections of the road requiring rehabilitation presented additional drainage problems. Since the road was so flat, large volumes of water accumulated in the median and filtered through into the layer works causing major degradation.

bidim[®] and Flo-pipe drainage system used to channel excess water.

A more robust, permanent pavement solution was therefore implemented in which they specified a **bidim[®] A4** and **Flo-pipe[®]** drainage system to control the ingress of water into the layer works. Success was achieved when an inspection revealed large volumes of water flowing from the **Kayduct** pipes into the storm water manholes.

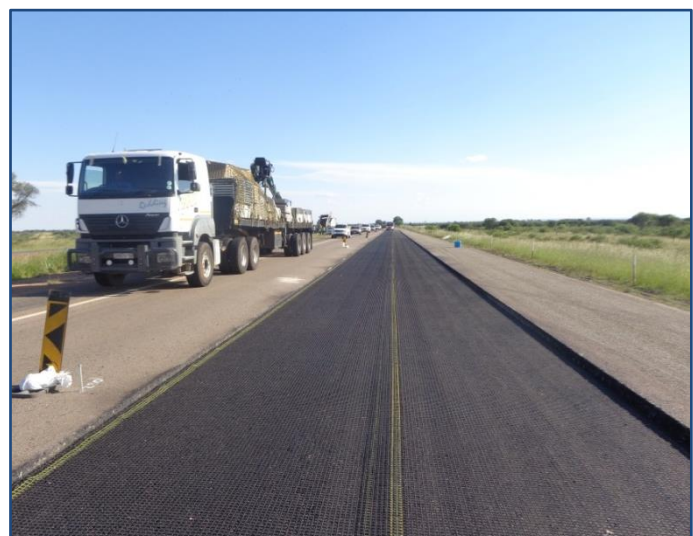
Glasgrid[®] laid over roads to effectively reinforce the asphalt layer.

Glasgrid[®], a polymer-modified, bitumen-coated, woven fibreglass grid was used to redirect crack stresses horizontally and to dissipate traffic-induced stresses as well as effectively reinforce the asphalt layer.
