### CANAL LINING

Stormwater Cut-off Canal  
Transnet Rail  
Tylden, Eastern Cape  
August 2019

Erosion protection lining of a  
stormwater cut-off canal

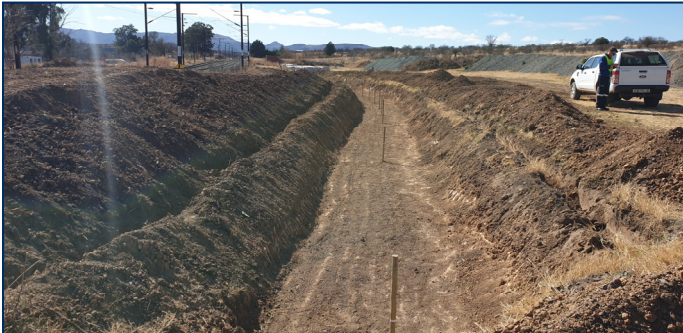
Completed earthworks

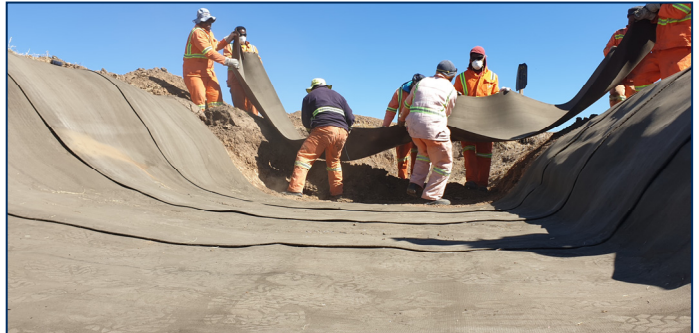
Installation of CC8

Concrete Canvas® CC8 was laid in transverse strips with tiled joints in the direction of flow effectively diverting stormwater flow away from the rail cutting and into the tributary feeding the Swart Kei River.

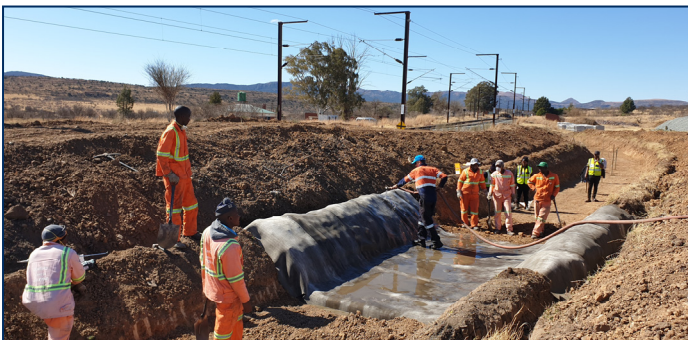
Installation - CC8 hydration process

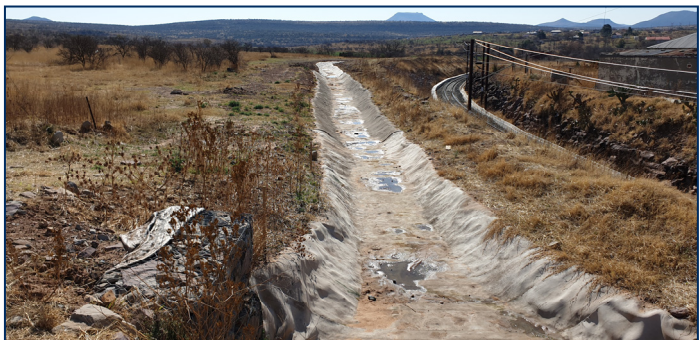
Completed northbound canal
