CC8™ Batched Rolls

A66(W) County Durham, UK

CC8™ used to prevent undercutting of the A66 Highway

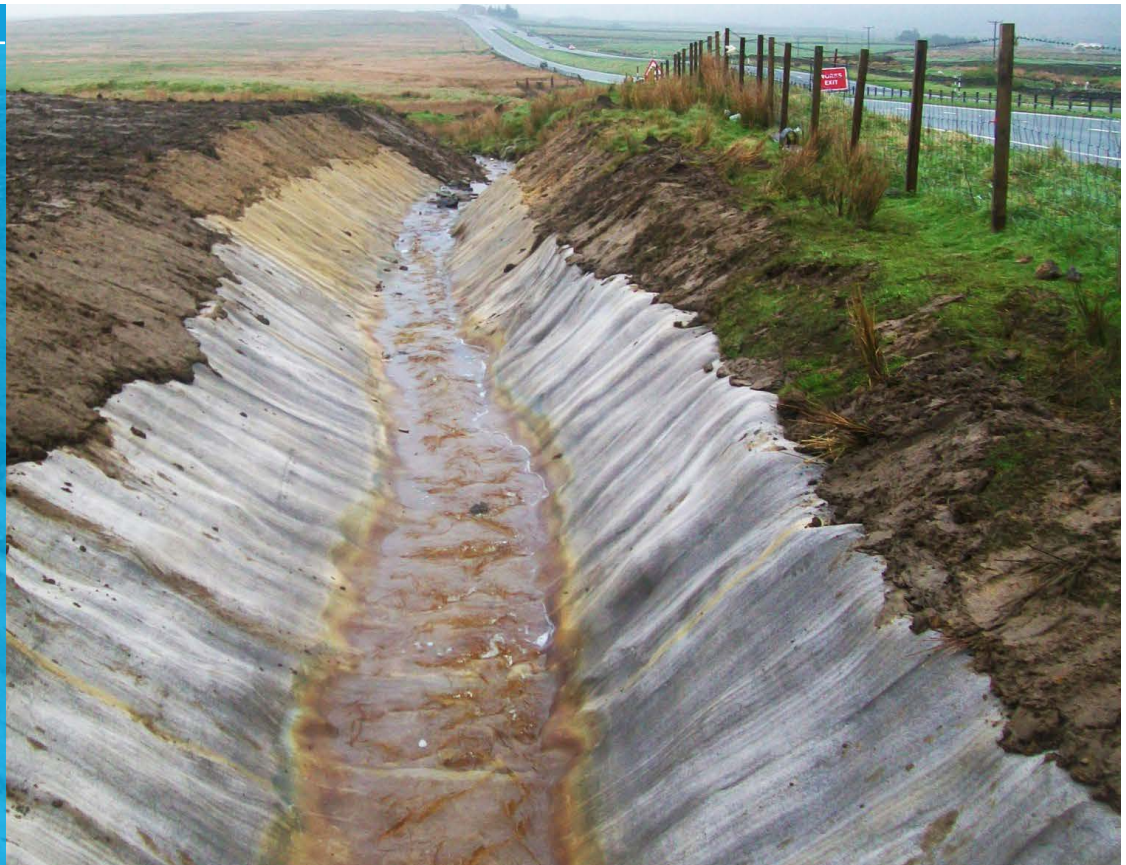
Completed installation

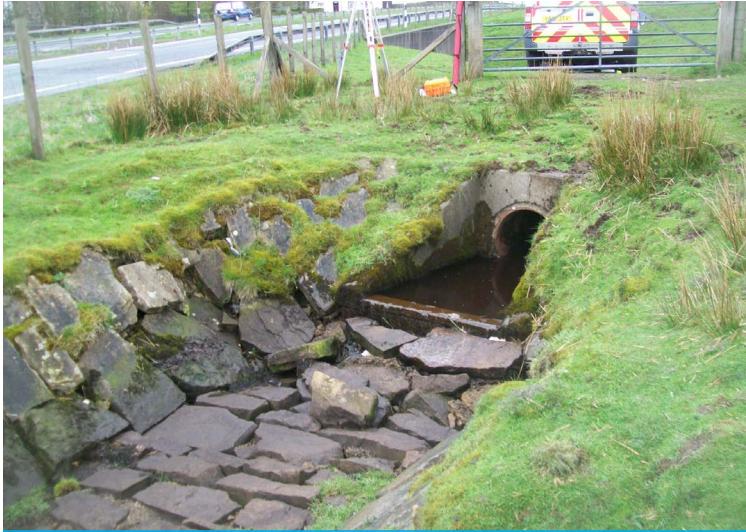
Site before works began

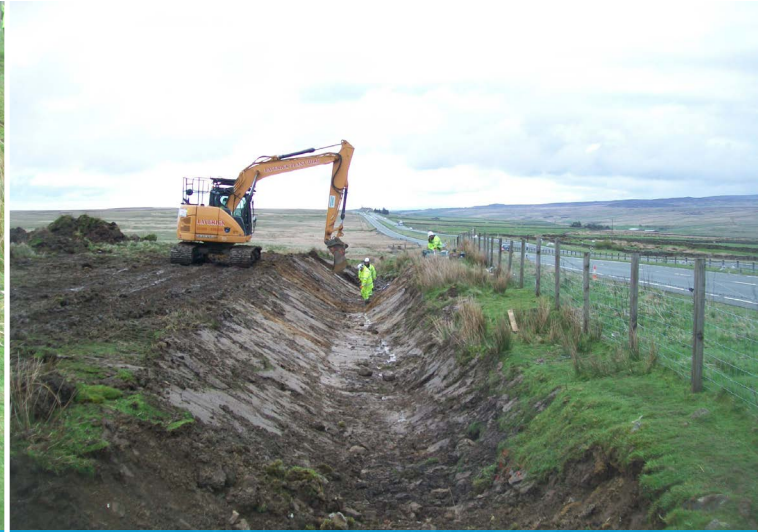
Grading

Installation was carried out by A-one+ Integrated Highway Services (Area 14). An excavator was used to re-profile the ditch and culvert before 30 batched rolls of CC8™ were delivered to site. The excavator located the batched rolls at sections of the ditch as required before they were unrolled by hand into position. The CC was laid progressively upstream, and pegged at the edges whilst allowing the live water course to flow under the material. Once CC had been installed along the length of the ditch, a concrete sandbag header wall was built on top of the last CC layer. This would allow the water from the culvert to flow over the CC as intended. The overlaps were mechanically jointed with screws at 200mm centres; the joints weren't sealed so as to create natural weep paths allowing water ingress into the ditch and preventing the build-up of hydrostatic pressure behind the CC. Post hydration, the ditch anchor trenches along the crest were backfilled to secure the CC in place and to provide a neat finish.

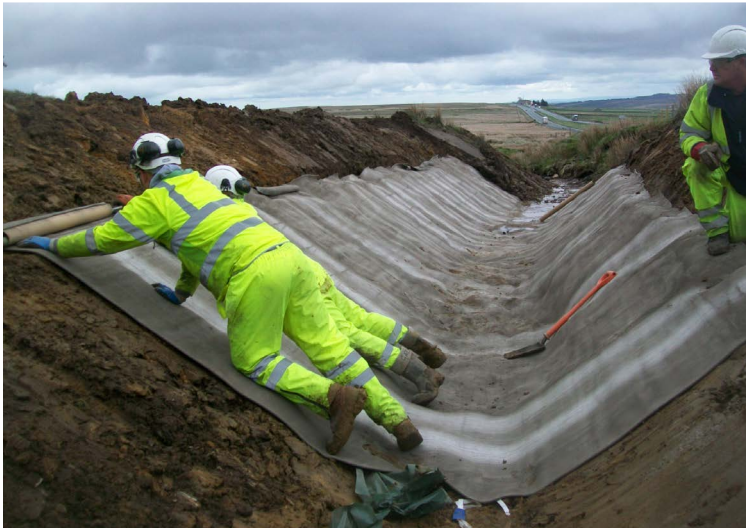
Batched CC8™ being unrolled

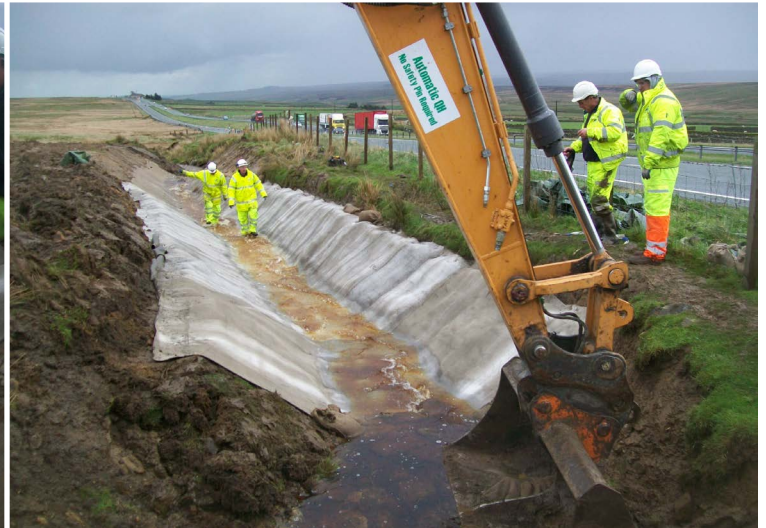
Allowing the live water course to hydrate the CC

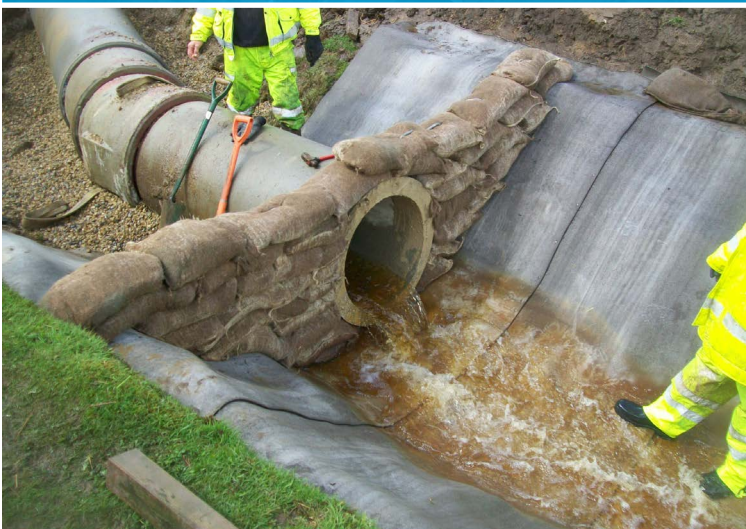
Concrete sandbag header constructed on top of the CC

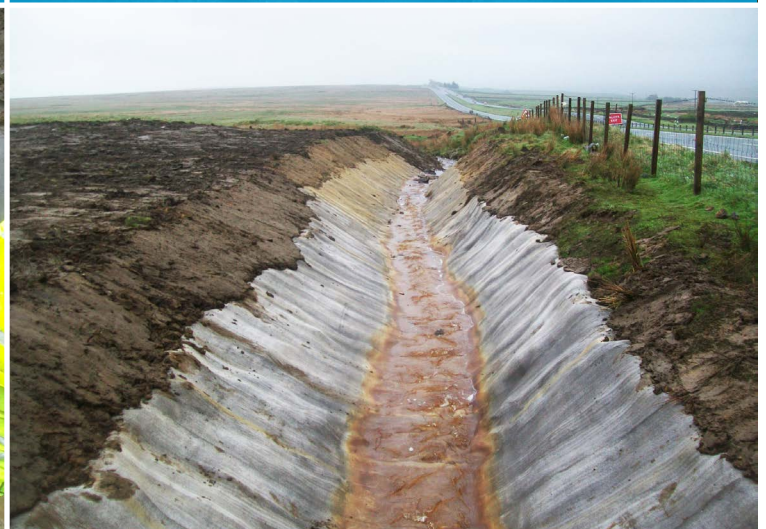
The finished project
