Bedwas Colliery Ditch Lining

CC CC13™ Bulk Rolls

i CC used to provide scour protection to a series of spoil tip drainage channels at a former colliery site in South Wales.

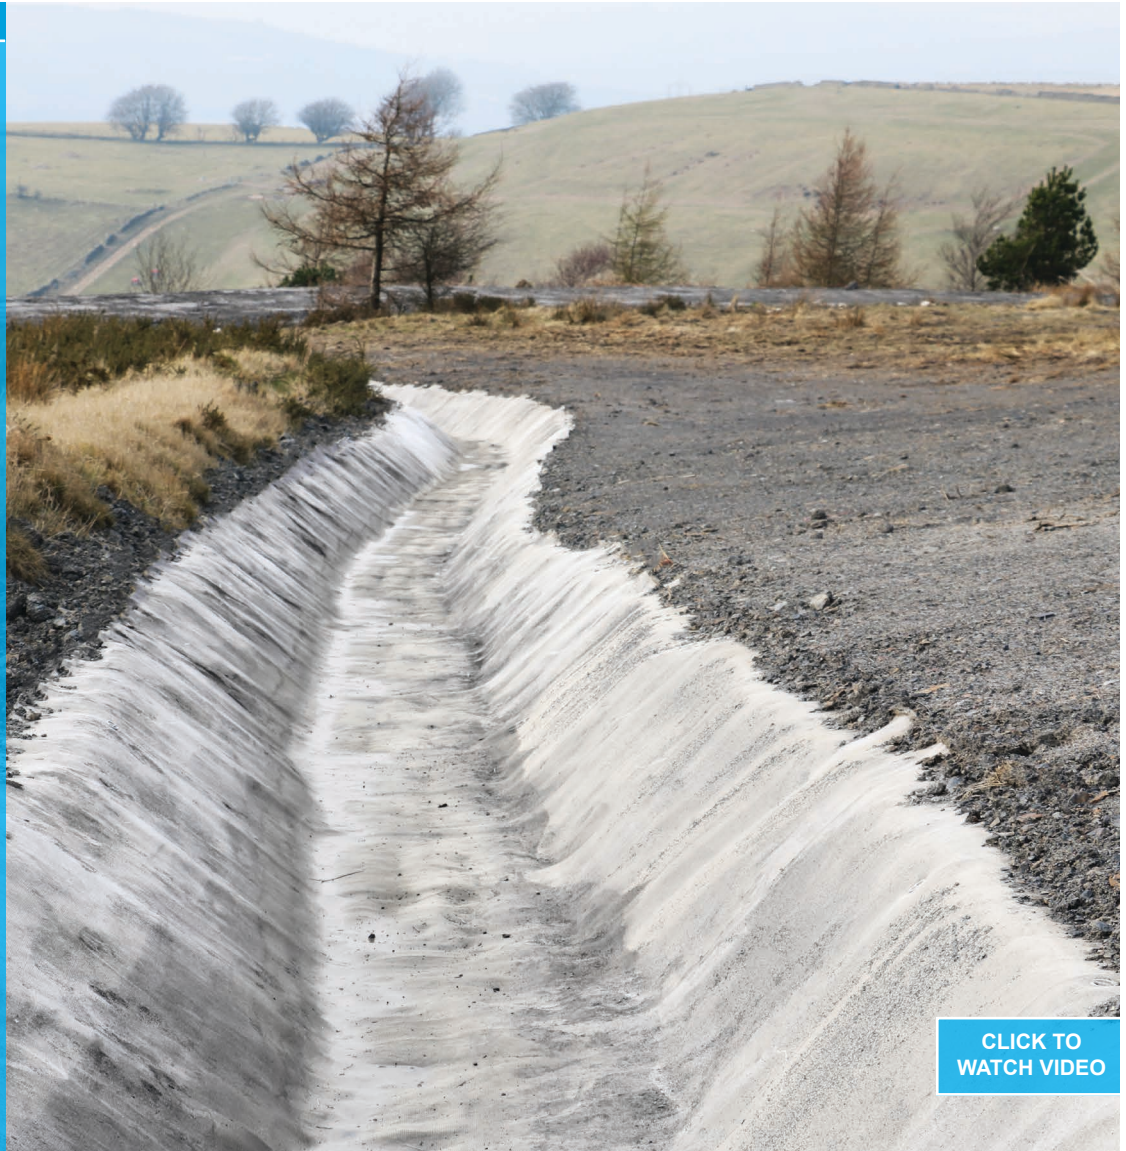
Completed CC lined drainage channel

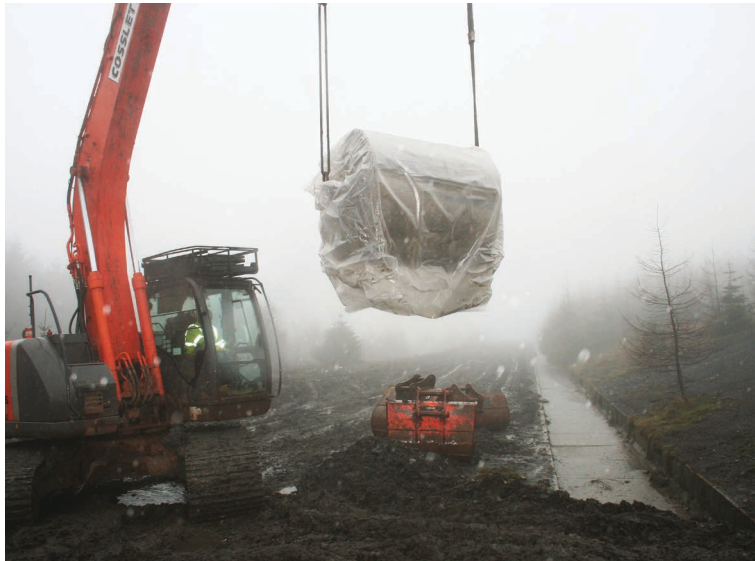
Phase 1 CC13™ Bulk Roll deployment in challenging weather conditions

The 2 hour delayed setting window meant that installation could continue in inclement weather, which would normally prevent conventional concrete solutions from being used. This was a particular advantage during phase 1 when the contractors, Cosslett Engineering, experienced torrential downpours during installation. Delays were avoided as installation was able to continue even in the extremely wet conditions.

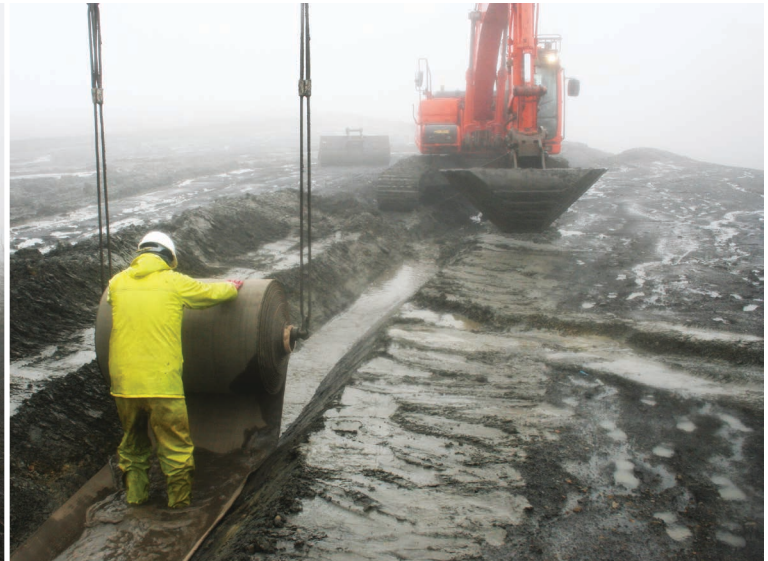
Phase 1 CC13™ Bulk Roll deployment in challenging weather conditions

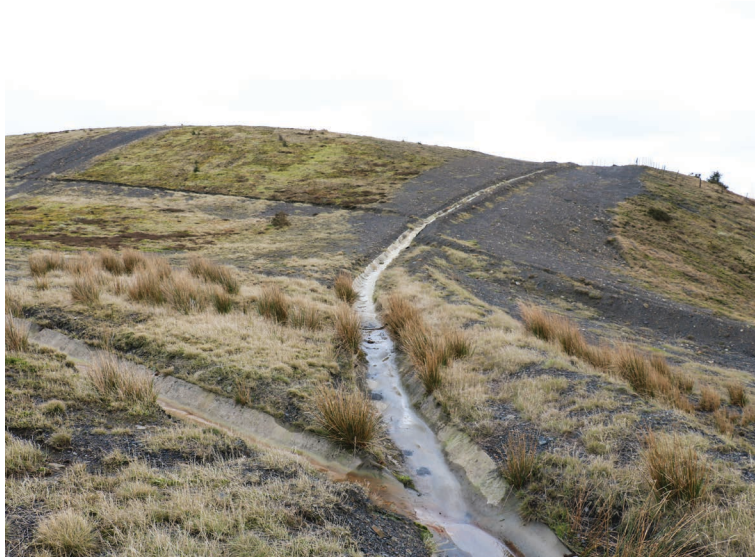
Phase 1 intersection 5 years after installation

Manufactured less than 10 miles from the site, CC has provided an effective and long lasting lining solution, preventing scouring of the drainage network across the spoil tip. The first phase of works, and its robustness demonstrated over the course of five maintenance free years, provided the confidence for Caerphilly County Borough Council to commission the second phase of works.

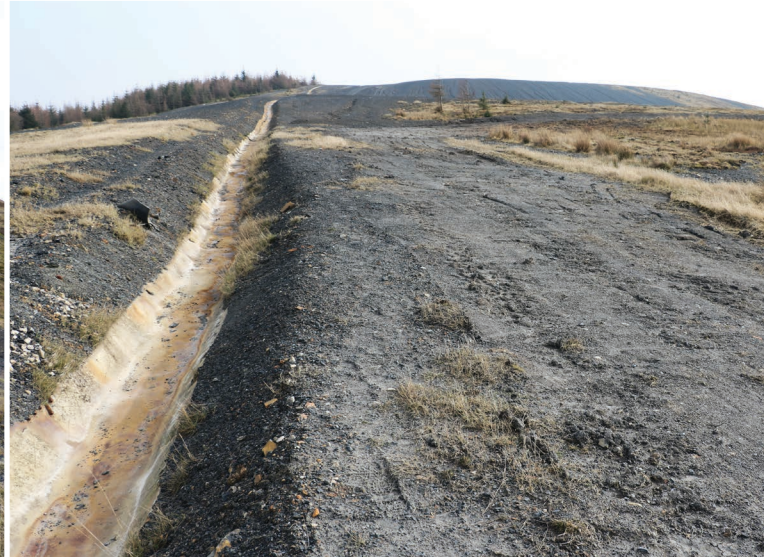
Channels show no signs of degradation and no requirement for maintenance

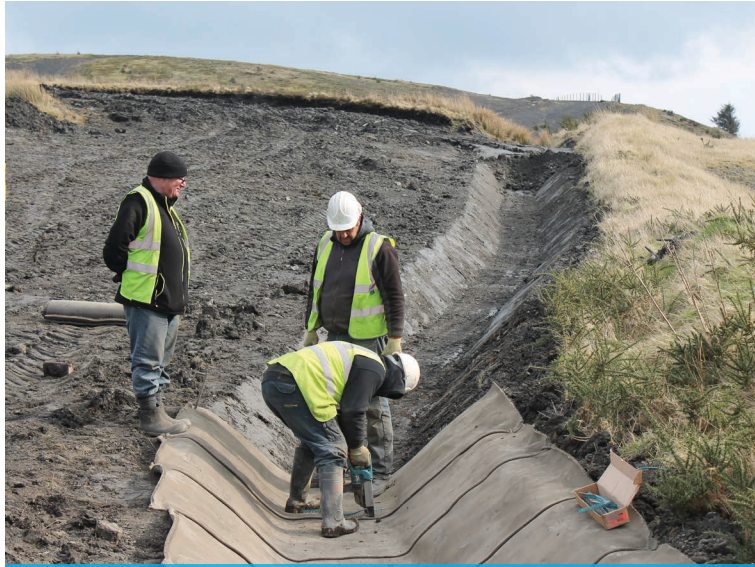
Phase 2 transverse lining

The second phase of works, installed by Jim Davies Civil Engineering, deployed CC13™ in both transverse and longitudinal lay ups to accommodate two sections of channel with distinct profiles. The first section measured approximately 1m in width and 300m in length. This section was lined using a single longitudinal layup, with bulk rolls of material deployed via a spreader beam in continuous lengths. The edges of this section were subsequently benched and backfilled to prevent water ingress undermining the channel. The second section was significantly wider, measuring approximately 2-3m across its width and approximately 1m in depth. It also incorporated a wide corner and several junctions with the incumbent phase 1 lined channels. CC13™ was laid transversely in this section, with the cut edges anchor trenched and backfilled. In both sections the CC was secured to the substrate using fixing pins and overlapped layers were screwed together at regular intervals using stainless steel screws.

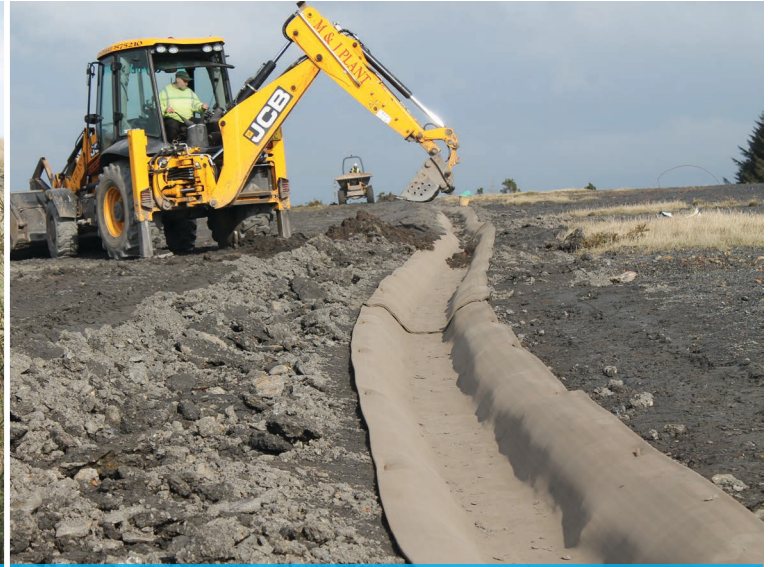
Phase 1 longitudinal lining

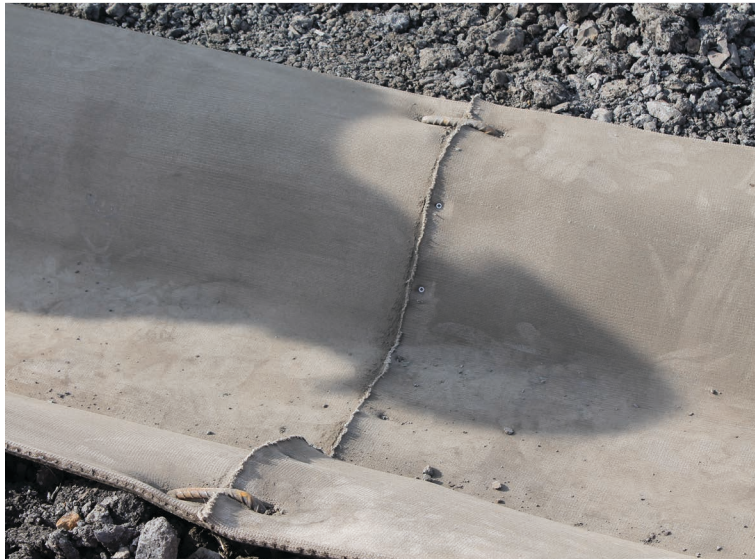
Longitudinal overlap detail

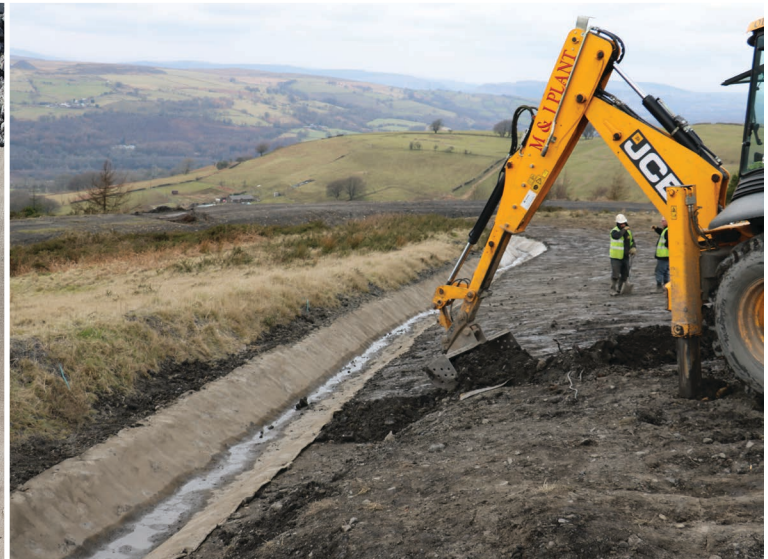
Backfilling

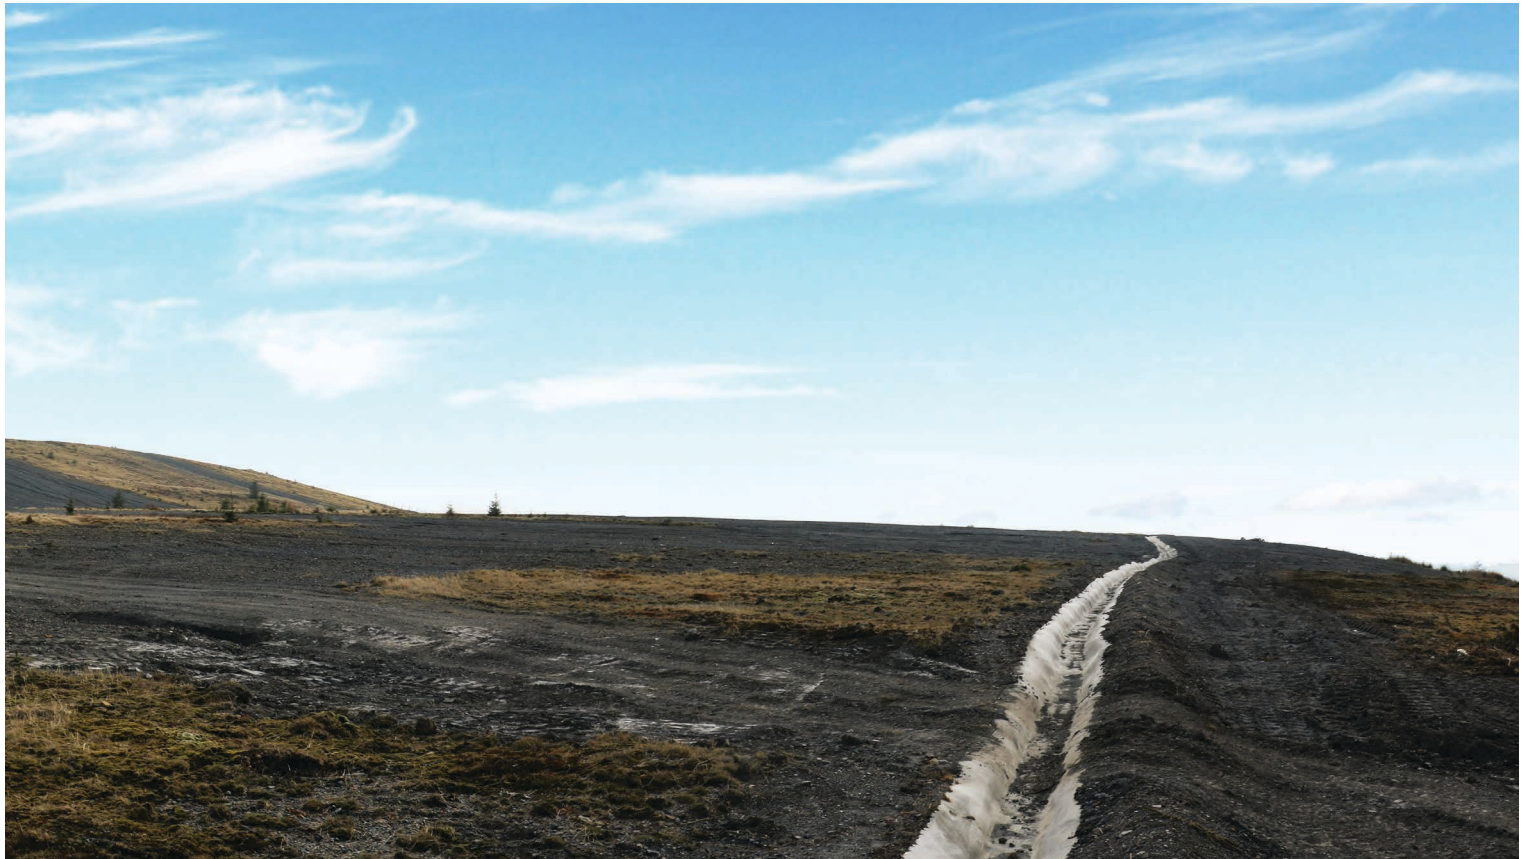
Phase 2 completed longitudinal section of ditch

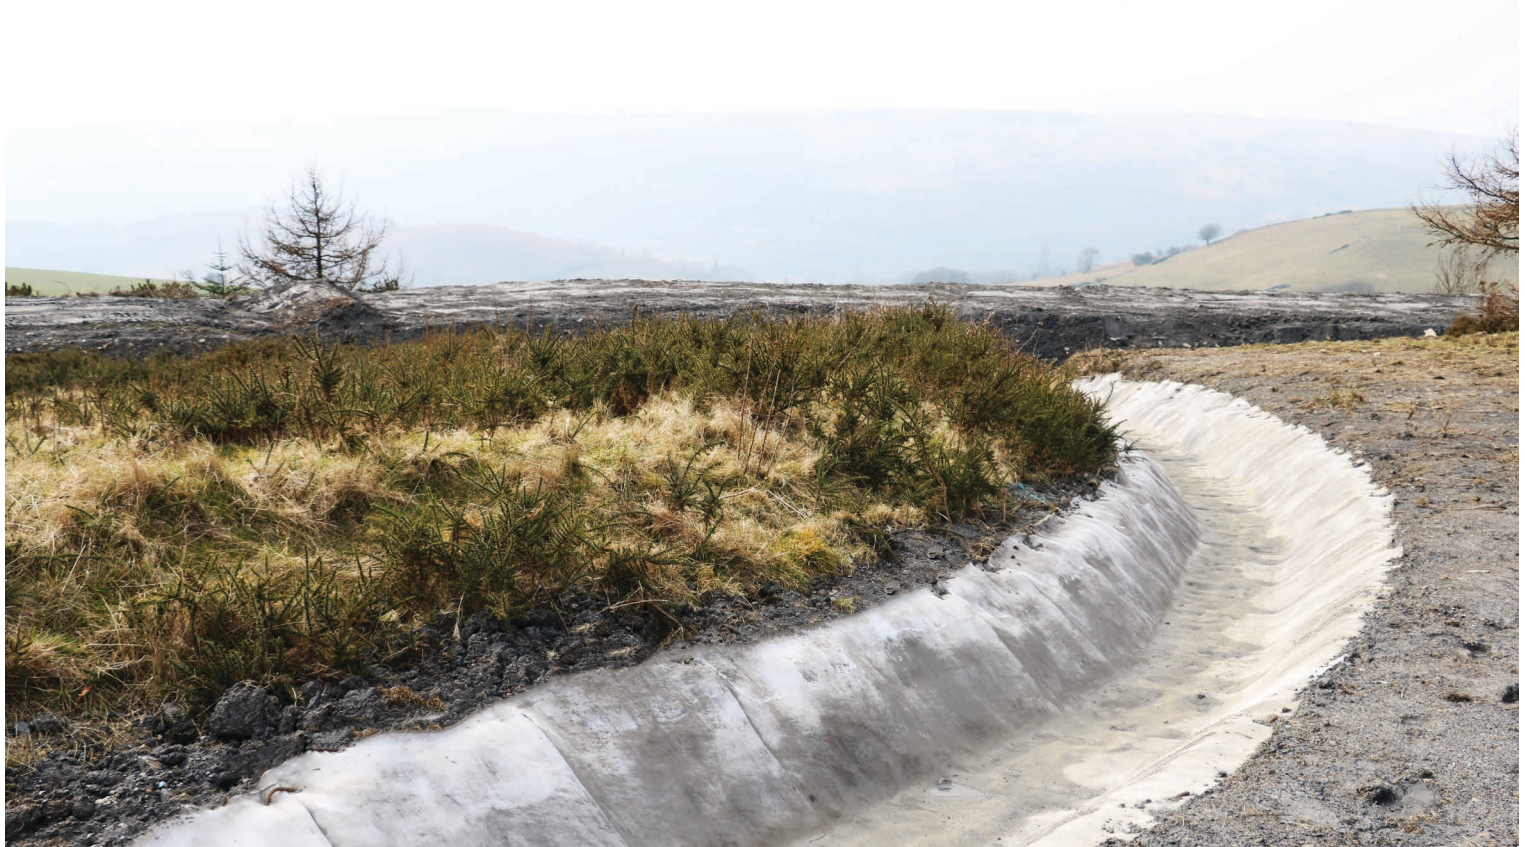
Phase 2 completed transverse corner section of ditch
